# OPERATIONAL ASSESSMENT REPORT

## LION'S HEAD MARINA

LION'S HEAD, ONTARIO

**Re: Operational Assessment of the Lion's Head Marina**

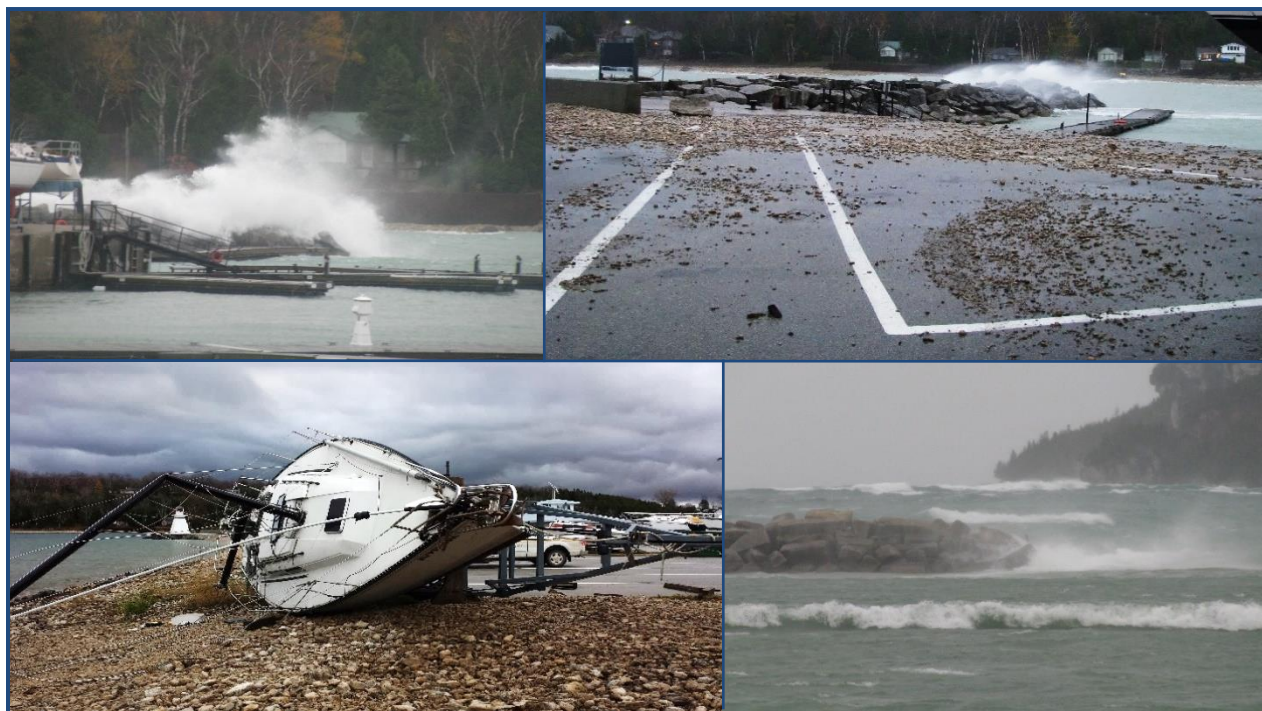
Figure 3-2: Weather and Damage During Storms at Lion's Head Marina

While the location and positioning of Lion's Head on the Bruce Peninsula allows the marina to be partially sheltered from most weather, the harbour is extremely exposed to weather originating from the north/northeast. Storms originating from these directions can produce very large and strong waves, which build over a fetch of between 85 and 110 km before reaching the harbour. These conditions overpower the harbour's armour stone breakwater wall, and bring strong winds, high waves and lakebed materials into the marina. These weather events also produce hazardous currents through the harbour mouth. These storms have caused damage to the vessels in the marina, both in and out of the water, as well as the marina's facilities, including its parking facilities, floating docks, lighthouse and breakwater (see Figure 3-2, below). These storms hit the marina a few times per year, and have become a costly hazard.

The winds at Lion's Head Marina are excessive. Due to the lack of sheltering, boats and docks in the marina can be hit directly by storms with wind speeds exceeding 40 knots. The docks are also subjected to large waves during these storm events, which can exceed heights of 4 feet in the vicinity of Docks A and B. The combination of these forces comprise this harbour's critical loading conditions, as evidenced by the heavy damage sustained by the floating docks during storms.

As mentioned in section 5.2.1, above, the floating docks in the Lion's Head Marina are concrete deadweight anchors. For the most part, these anchors are capable of holding their docks in place. However, due to the extreme and severe weather conditions acting on the floating dock system, the floating dock system fails. Planmac does not believe, however, that the failure of the docks during storms is a result of the anchoring method. The docks are subjected to such large forces during these events that if a stronger anchor were able to hold the docks in place, they would simply fall apart and detach. While past storms have caused anchors to shift and move, they have also caused welded steel joints to tear apart and anchor rode to snap.

However, Planmac recommends actions be taken to better shelter the marina's floating dock system from the weather conditions that currently result in a great deal of damage to these docks. Changes should be made to the breakwater system to expand the sheltered area of the harbour to at least reduce the impact of existing issues. If these measures are put in place, it will address the cause of the majority of the operational issues associated with the current floating dock system.

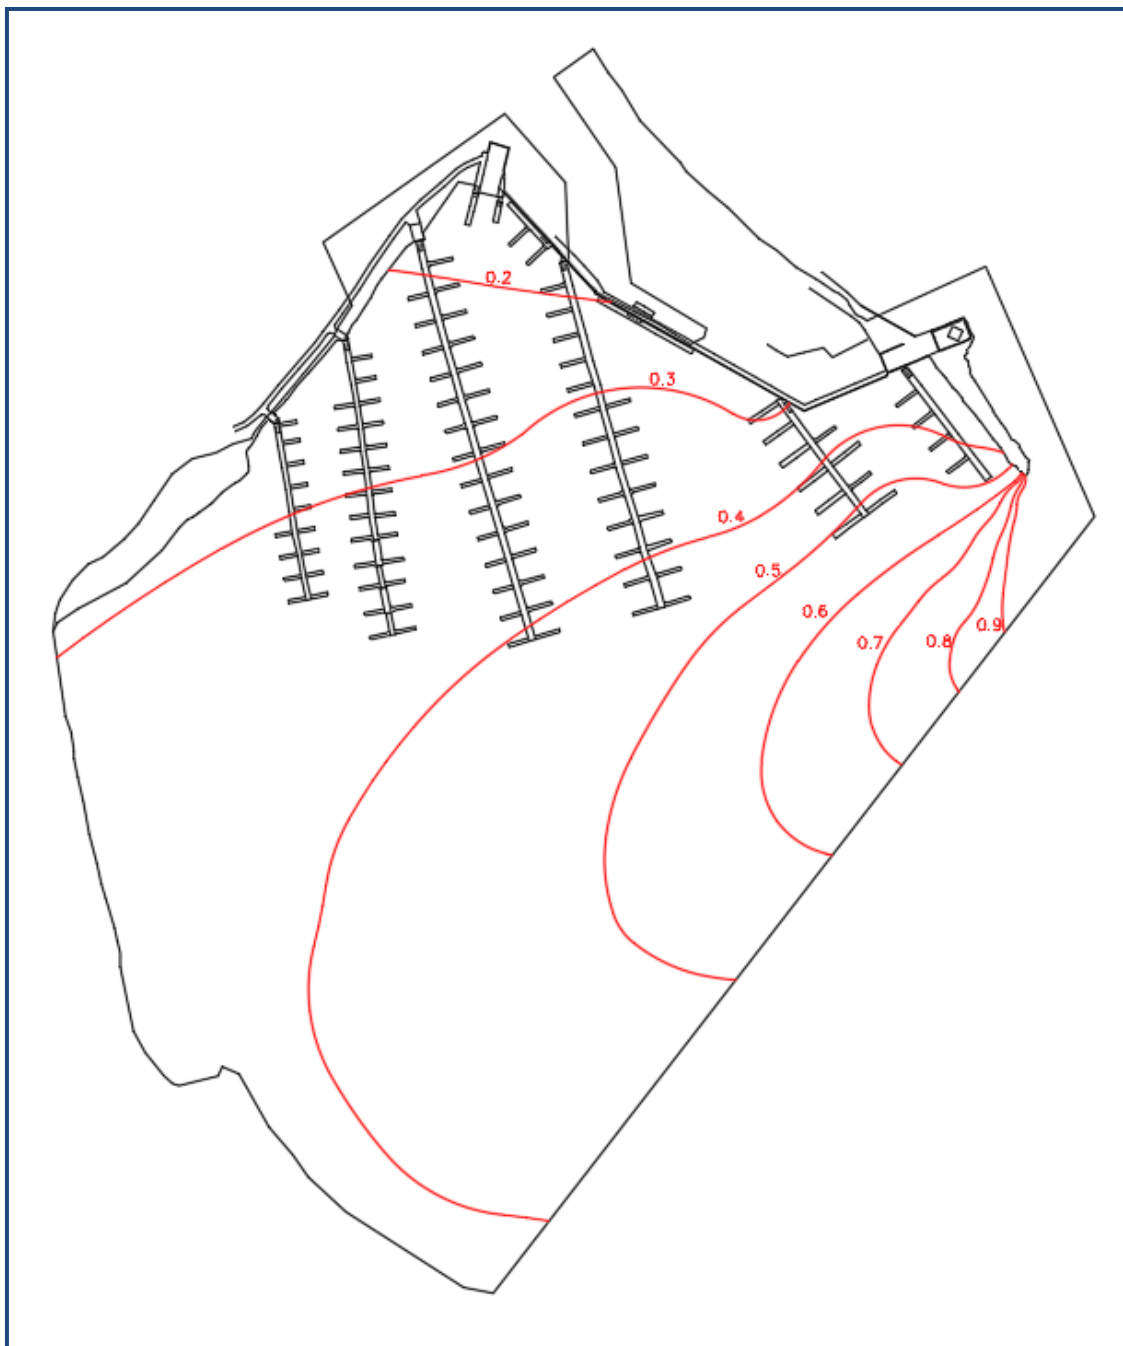
Figure 6-2: Contour Map of Wave Heights During Typical Storm Events

Although the area of the harbour currently occupied by Dock A and Dock B is behind the breakwater wall, it still experiences very rough conditions during storms. While some larger waves are able to overtop the wall, most of the damage is caused by the proximity of the end of the wall to these docks. Because of its positioning, the wall is not able to properly diffract and de-power the waves before they hit enter this area. Instead, it diffracts large and high-powered waves directly into the harbour wall, which reflects the waves back into the area, causing even larger waves. For a contour map of wave heights within the marina's property limits during typical storm events, expressed in fractions of incident wave height, see Figure 6-2, below. This diagram is representative of the height, period and speed of waves observed in on-site footage

and data taken during storm events and provided by marina staff. The results of this wave diffraction modeling demonstrate why the outermost fingers of Dock A and the last segment of Dock B often sustain the heaviest damage during extreme weather events.

We recommend that the existing breakwater structure be removed, and, where possible, salvaged and rebuilt into a new armour stone breakwater structure. This new structure would be taller than the existing structure to more adequately shelter the marina from Lion's Head's strong winds, and would be longer to provide more protection from diffracted waves. The new structure would be built to the east of the existing structure to provide more useable space within the marina.

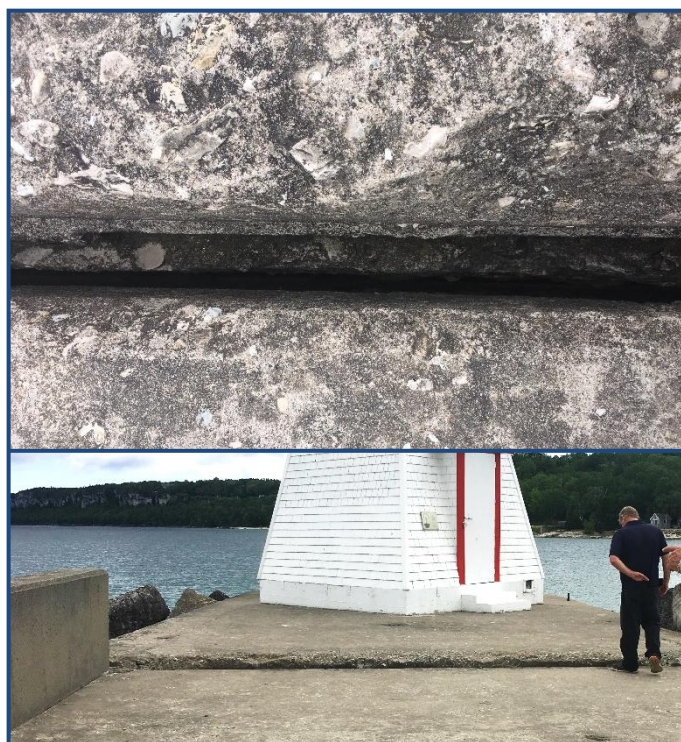
Figure 7-1: Separation of Concrete Lighthouse Base Slab from Concrete Wharf

At the site meeting, we observed an elevation gap that had developed between the marina pier and walkway and the concrete slab supporting the Lion's Head Lighthouse (see Figure 7-1 for top and side view of separation). The lighthouse base has risen when compared to the concrete wharf, and has also shifted to the east, away from the wharf. Water is visible in the gap produced between the two concrete structures, and waves coming in from Georgian Bay can be seen to continue through this gap, toward the armour stone breakwater structure on the south side. The slab's other edges are protected by armour stone. This stone barrier has deteriorated slightly, to a similar degree as the neighbouring breakwater structure. The lighthouse base was originally poured onto rocks and fill material, which has washed out, creating a void underneath. This has caused the slab to rotate and slant to the east.

The existing concrete slab supporting the Lion's Head Lighthouse has rotated and shifted due to erosion of fill materials. To remedy this, Planmac recommends the existing slab be demolished and replaced, with the addition of a protective sheet pile wall (as per Section 7.2.3.). This will provide long-term durability and strength to the lighthouse foundation.

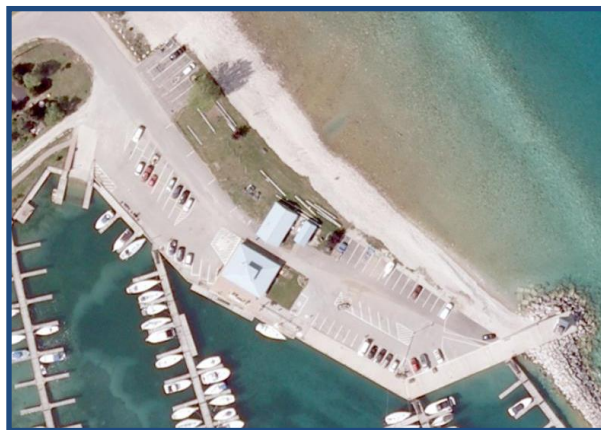
Figure 8-1: Parking Facilities at the Lion's Head Marina.  
*\*Please note that this satellite image is out of date and the marina parking layout has since been rearranged slightly.*

Therefore, the existing parking facilities at the Lion's Head Marina are inadequate. Note that should a larger portion of the slips be used commercially, the demand for parking will increase.
