# **Tree Inventory and Preservation Plan**

**65-69 Bridge St**

**Elora, ON**

**SUBJECT:** Tree Inventory and Preservation Plan for 65-69 Bridge Street.

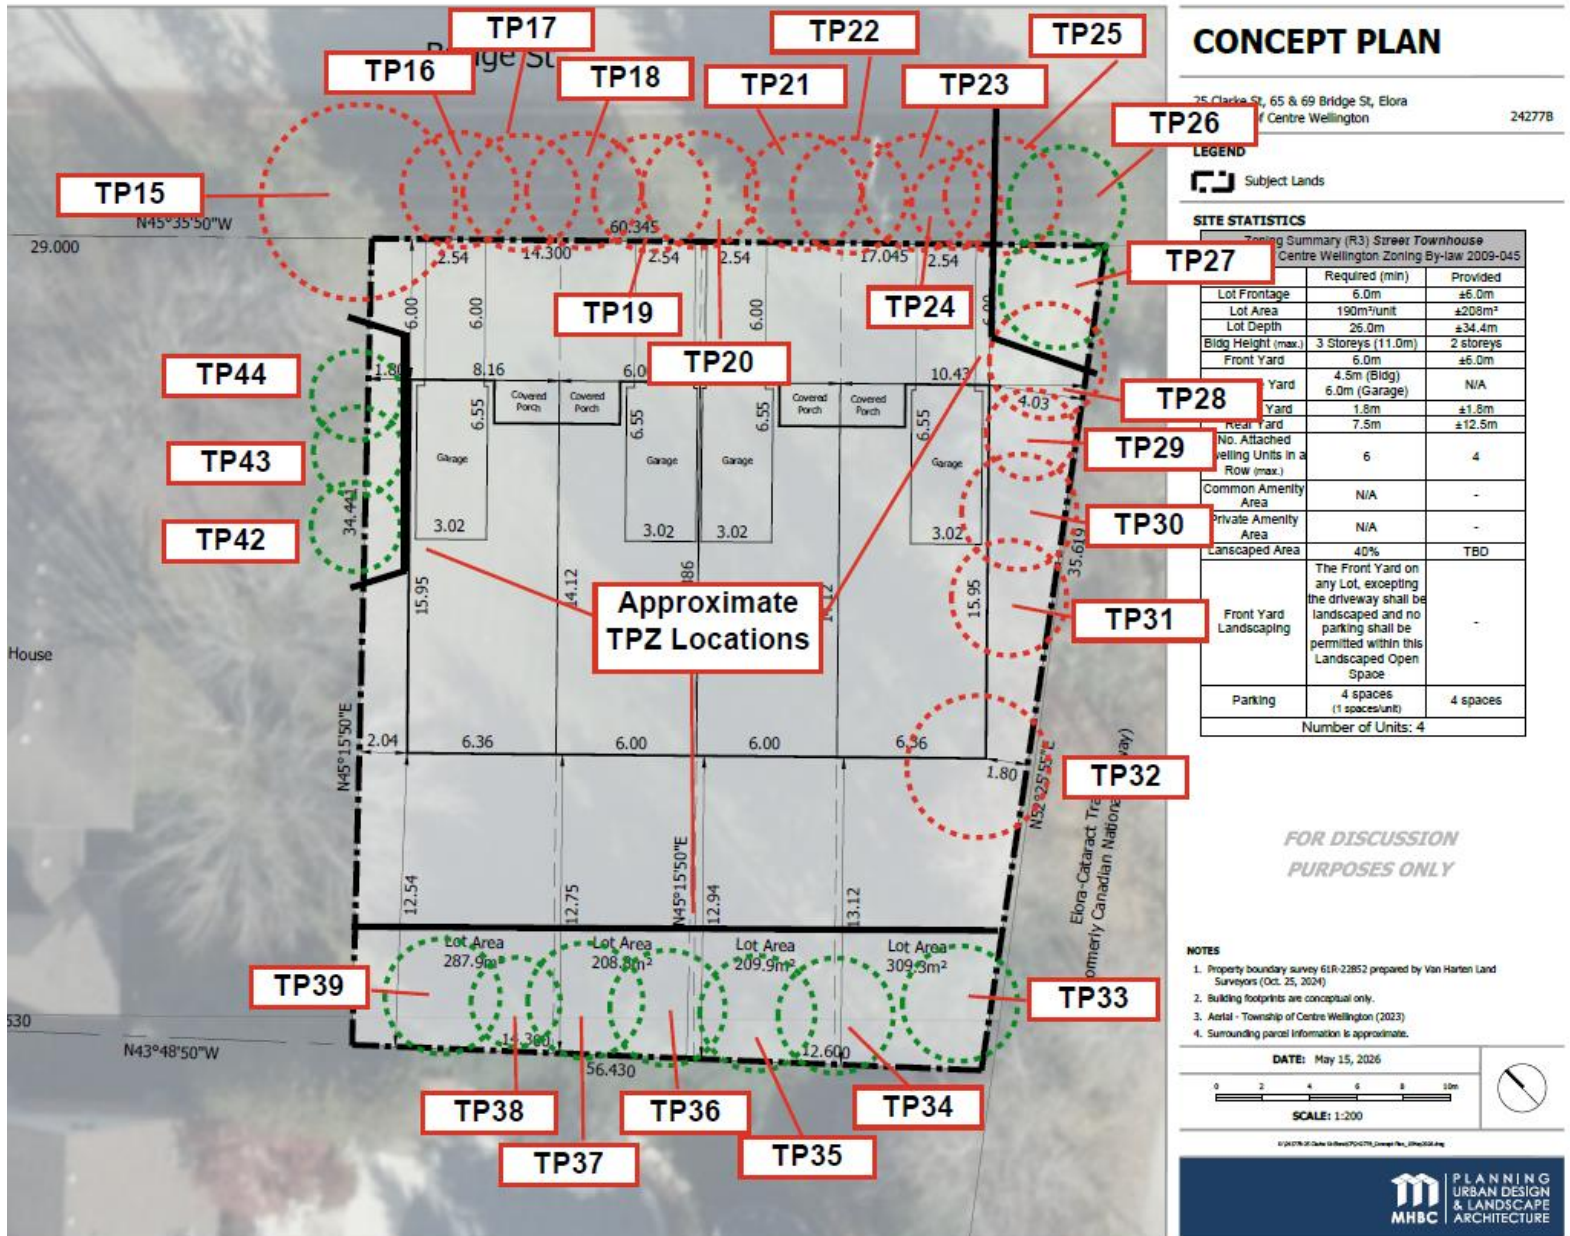
### Site Plan

All trees inventoried are listed below and a final recommendation given based on current health and condition, and the impact of the proposed construction activities. These trees and their approximate locations are marked on the survey. Trees and tree groups to remove are indicated by **RED circles** on the survey and trees and tree groups to preserve are indicated by **GREEN circles**. The full detailed tree inventory can be found in Appendix C.

| Final Recommendation | ID# | Total Number of Trees |
|---|---|---|
| Remove due to health or condition | TP 28, 29 | 2 |
| Remove due to development<br>(Private tree) | TP 30, 31, 32 | 3 |
| Remove due to development<br>(Municipal tree) | TP 15, 16, 17, 18, 19, 20, 21,<br>22, 23, 24, 25 | 11 |
| Preserve | TP 26, 27, 33, 34, 35, 36, 37,<br>38, 39, 42, 43, 44 | 12 |

Note: all tree locations are approximate and should be confirmed by survey where necessary

Prior to any phase of construction, all required tree removals should be completed.
