# 2022 Annual Monitoring Report Escott Waste Disposal Site (A441703)

Prepared for The Corporation of the  
Township of Leeds and thousand Islands

March 31, 2023

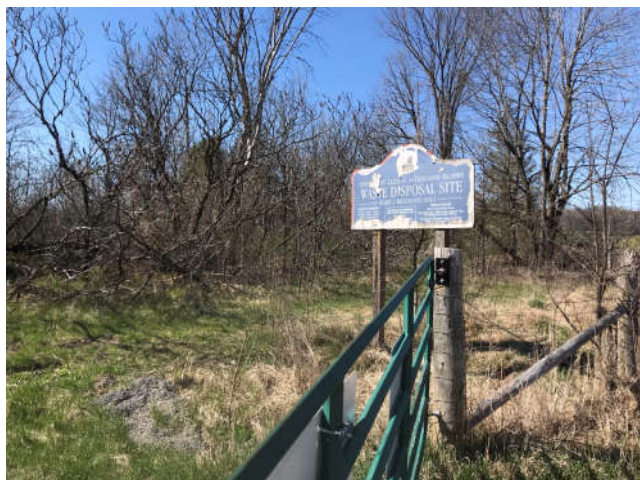
3. View of the sign at front gate.  
April-2022

During the Malroz inspections in the spring, staff noted that the entrance signage is shows signs of degradation (Appendix G). Road grading was occurring during spring sampling, and no significant ponding was observed in the fall. Litter was noted at both the spring and fall sampling events.

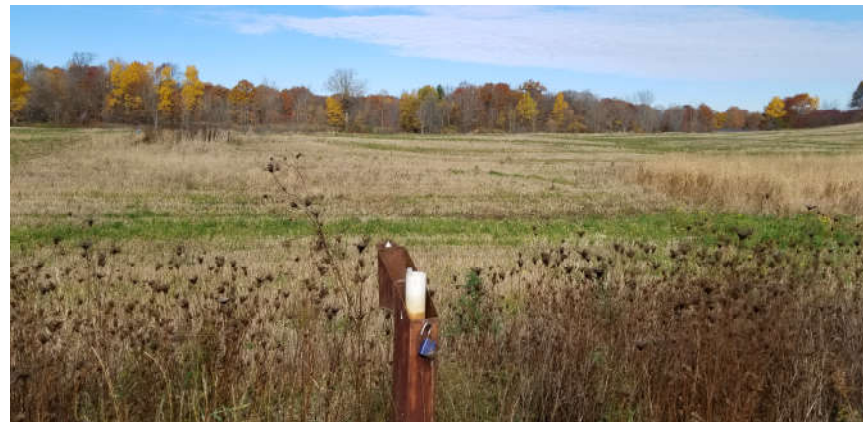
6. OW12  
October-2022

- BW4 and OW11R1 which sustained damage after being struck by equipment (seals in both appear to be compromised) were replaced with MW106 and MW105 respectively on December 1, 2022,
- OW12 which has a pinched piezometer approximately 40 cm from the top of the pipe (function not compromised), and
- OW14 which was damaged during the reclaiming of capacity in Fall of 2022 and is proposed to be replaced in 2023 following final contouring of the area.

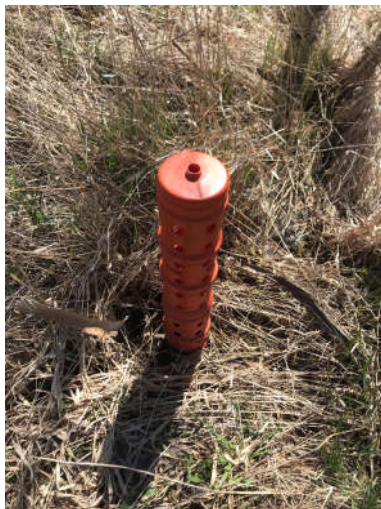
9. HBI  
April-2022

During the fall sampling event, the concentrations of iron and manganese measured at HBI were found to be significantly higher than those measured at the other monitoring stations. These concentrations were also higher than historical levels.

The observed elevation in iron and manganese levels may be attributed to the impediment of water flow within the pipe, leading to water pooling at the inlet. The high temperatures measured at this station are indicative of a potential blockage in the pipe, which could be contributing to the observed increase in iron and manganese concentrations. The Hickenbottom and associated underground pipe is related to tile drainage managed by the landowner and should the pipe continue to appear blocked, amendment to the monitoring program may be considered.

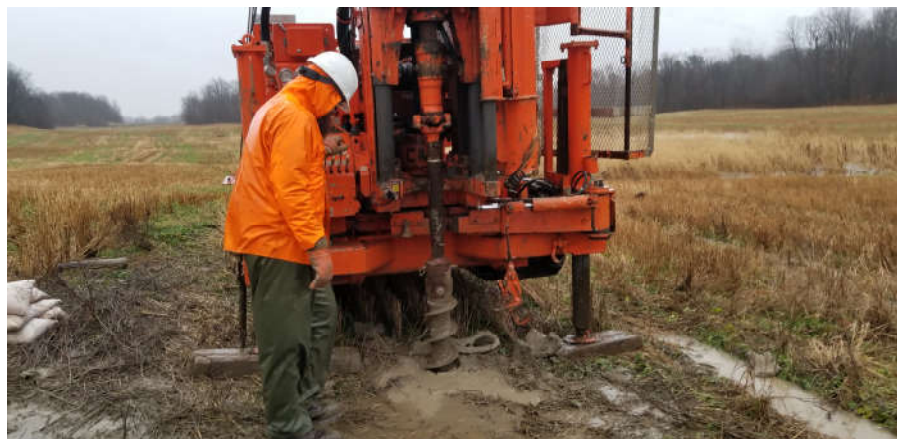
11. OW11-R1 and BW4 re-install  
November-2022

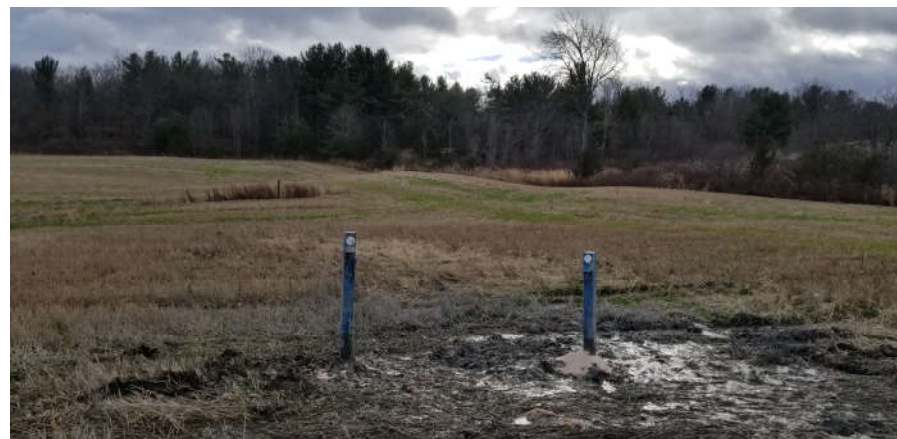
12. Newly installed MW105 (Left) and  
MW106 (Right)  
November-2022

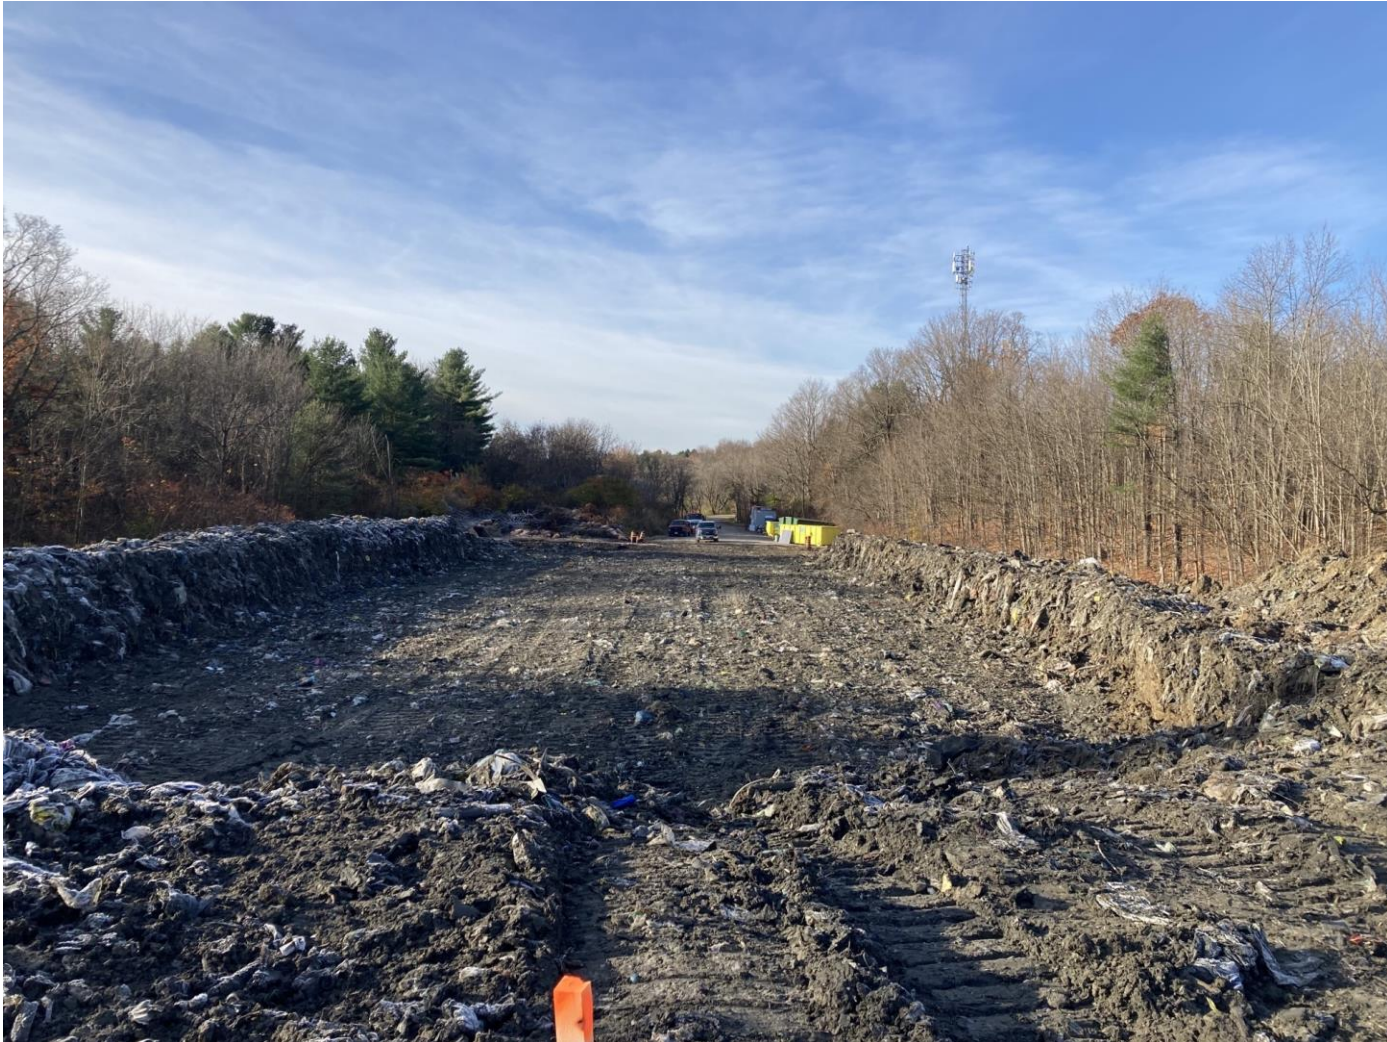
13. Results of work undertaken by the Township to reclaim capacity.

The Escott WDS is an active site currently accepting non-hazardous solid waste. A Closure Plan was approved for the Site; however, considering the work undertaken by the Township in 2022 to reclaim capacity and compact garbage, the landfill could have up to 19 years of capacity remaining.
