**Township of Leeds and the Thousand Islands**

**Briar Hill Waste Disposal Site  
2025 Annual Monitoring**

This document has been prepared by Malroz Engineering Inc. (Malroz) on behalf of the Township of Leeds and the Thousand Islands (TLTI), in fulfilment of Conditions 6(6) and 6(7) of Amended Environmental Compliance Approval (ECA) No. A442103.

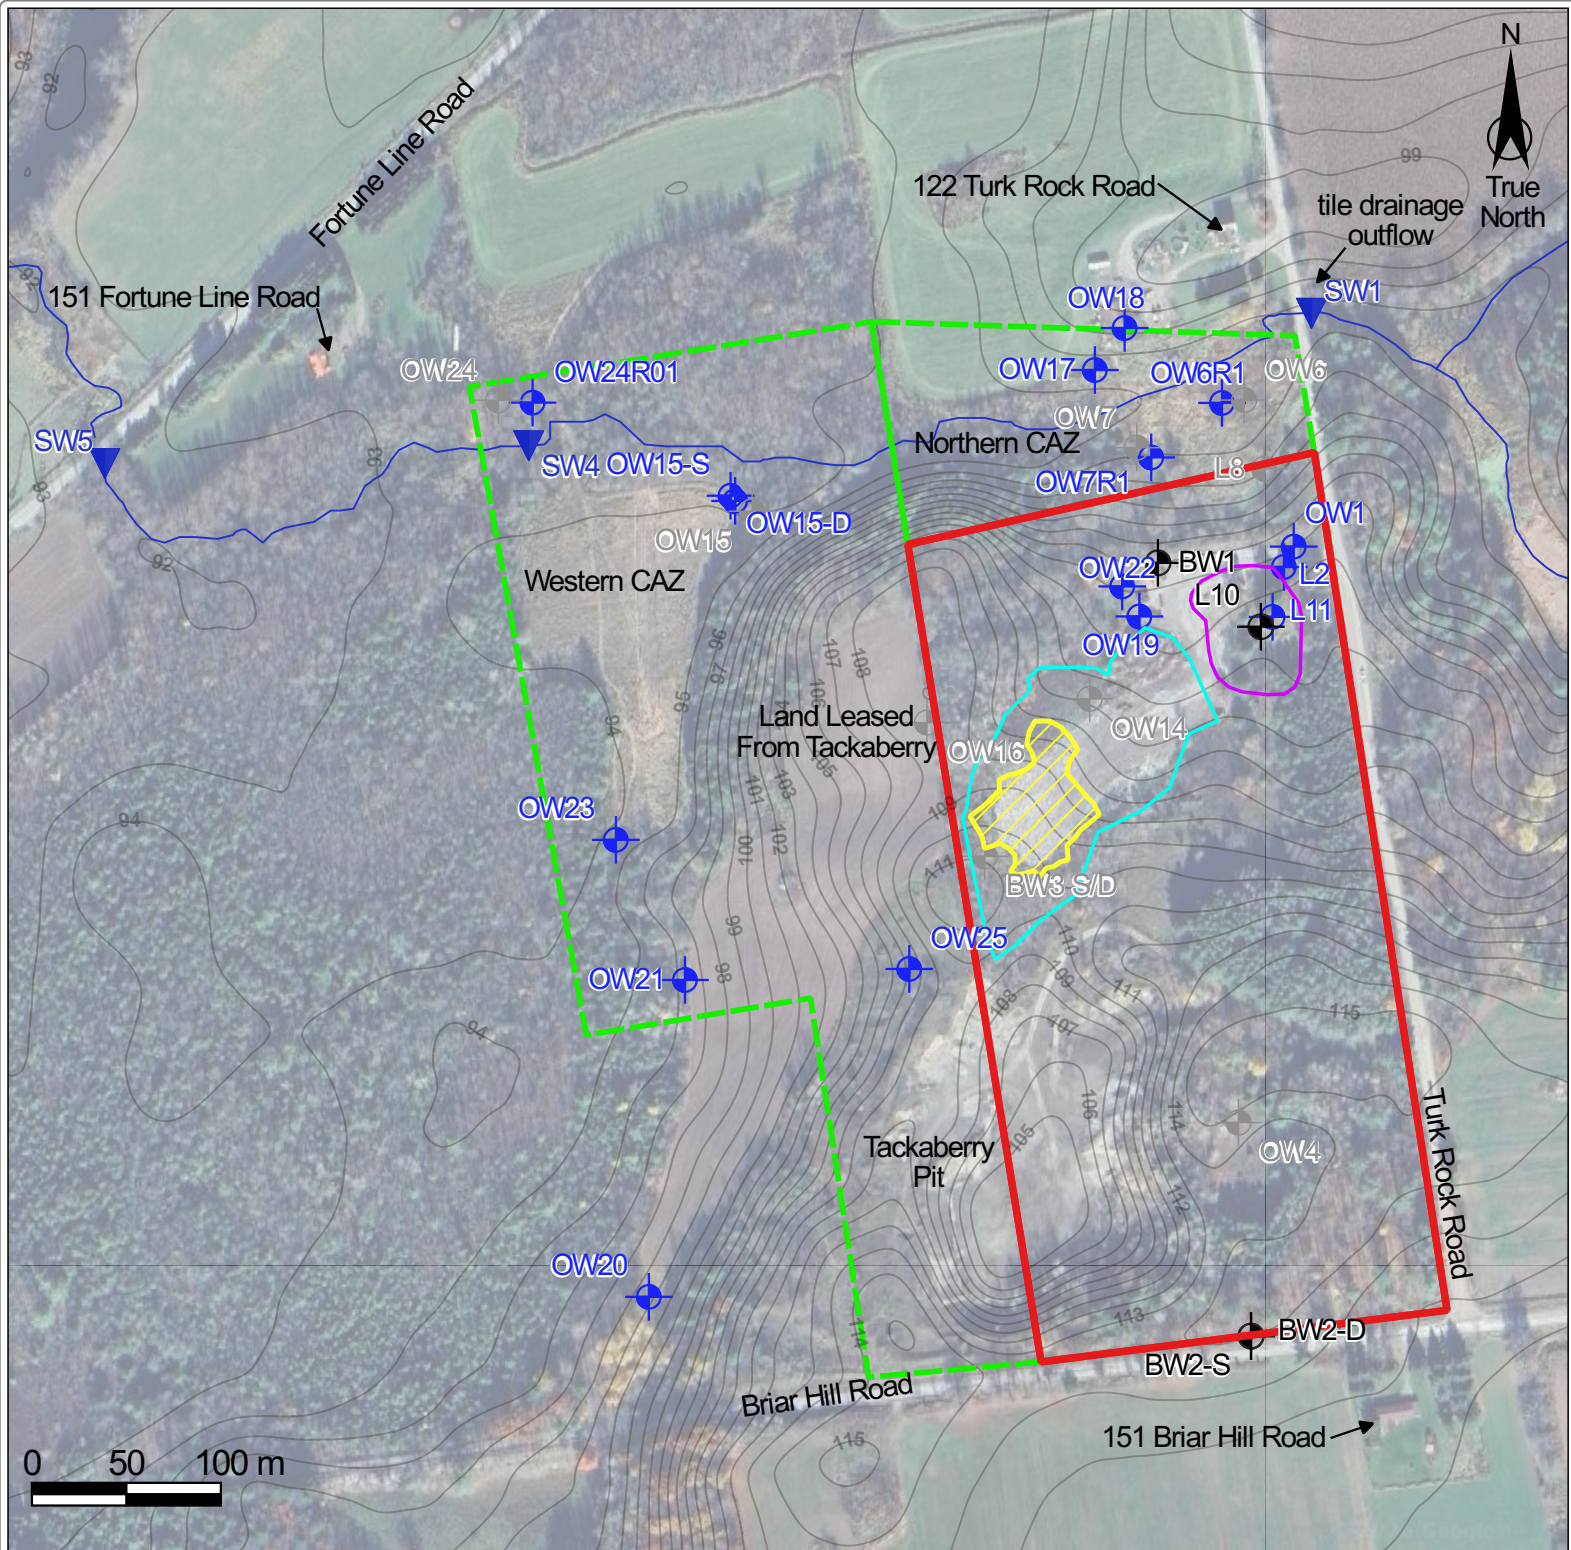
- approximate site boundary
- approximate CAZ boundary
- approximate current landfill area
- ▨ active landfill area
- approximate old landfill area
- approximate topographic contours (MNRF, 2024)
- ⊕ approximate deep monitoring well location
- ⊕ approximate shallow monitoring well location
- ▼ approximate surface water monitoring location
- stream

The Site has an approved waste volume of 85,600 cubic meters (including cover); however, this volume does not include the waste deposited prior to May 2003 within the 1.5 hectare area of the old landfill. The Site is actively landfilling non-hazardous waste materials from within the boundaries of TLTI. The current Site property boundary and fill area is shown on Figure 2 (Appendix A).

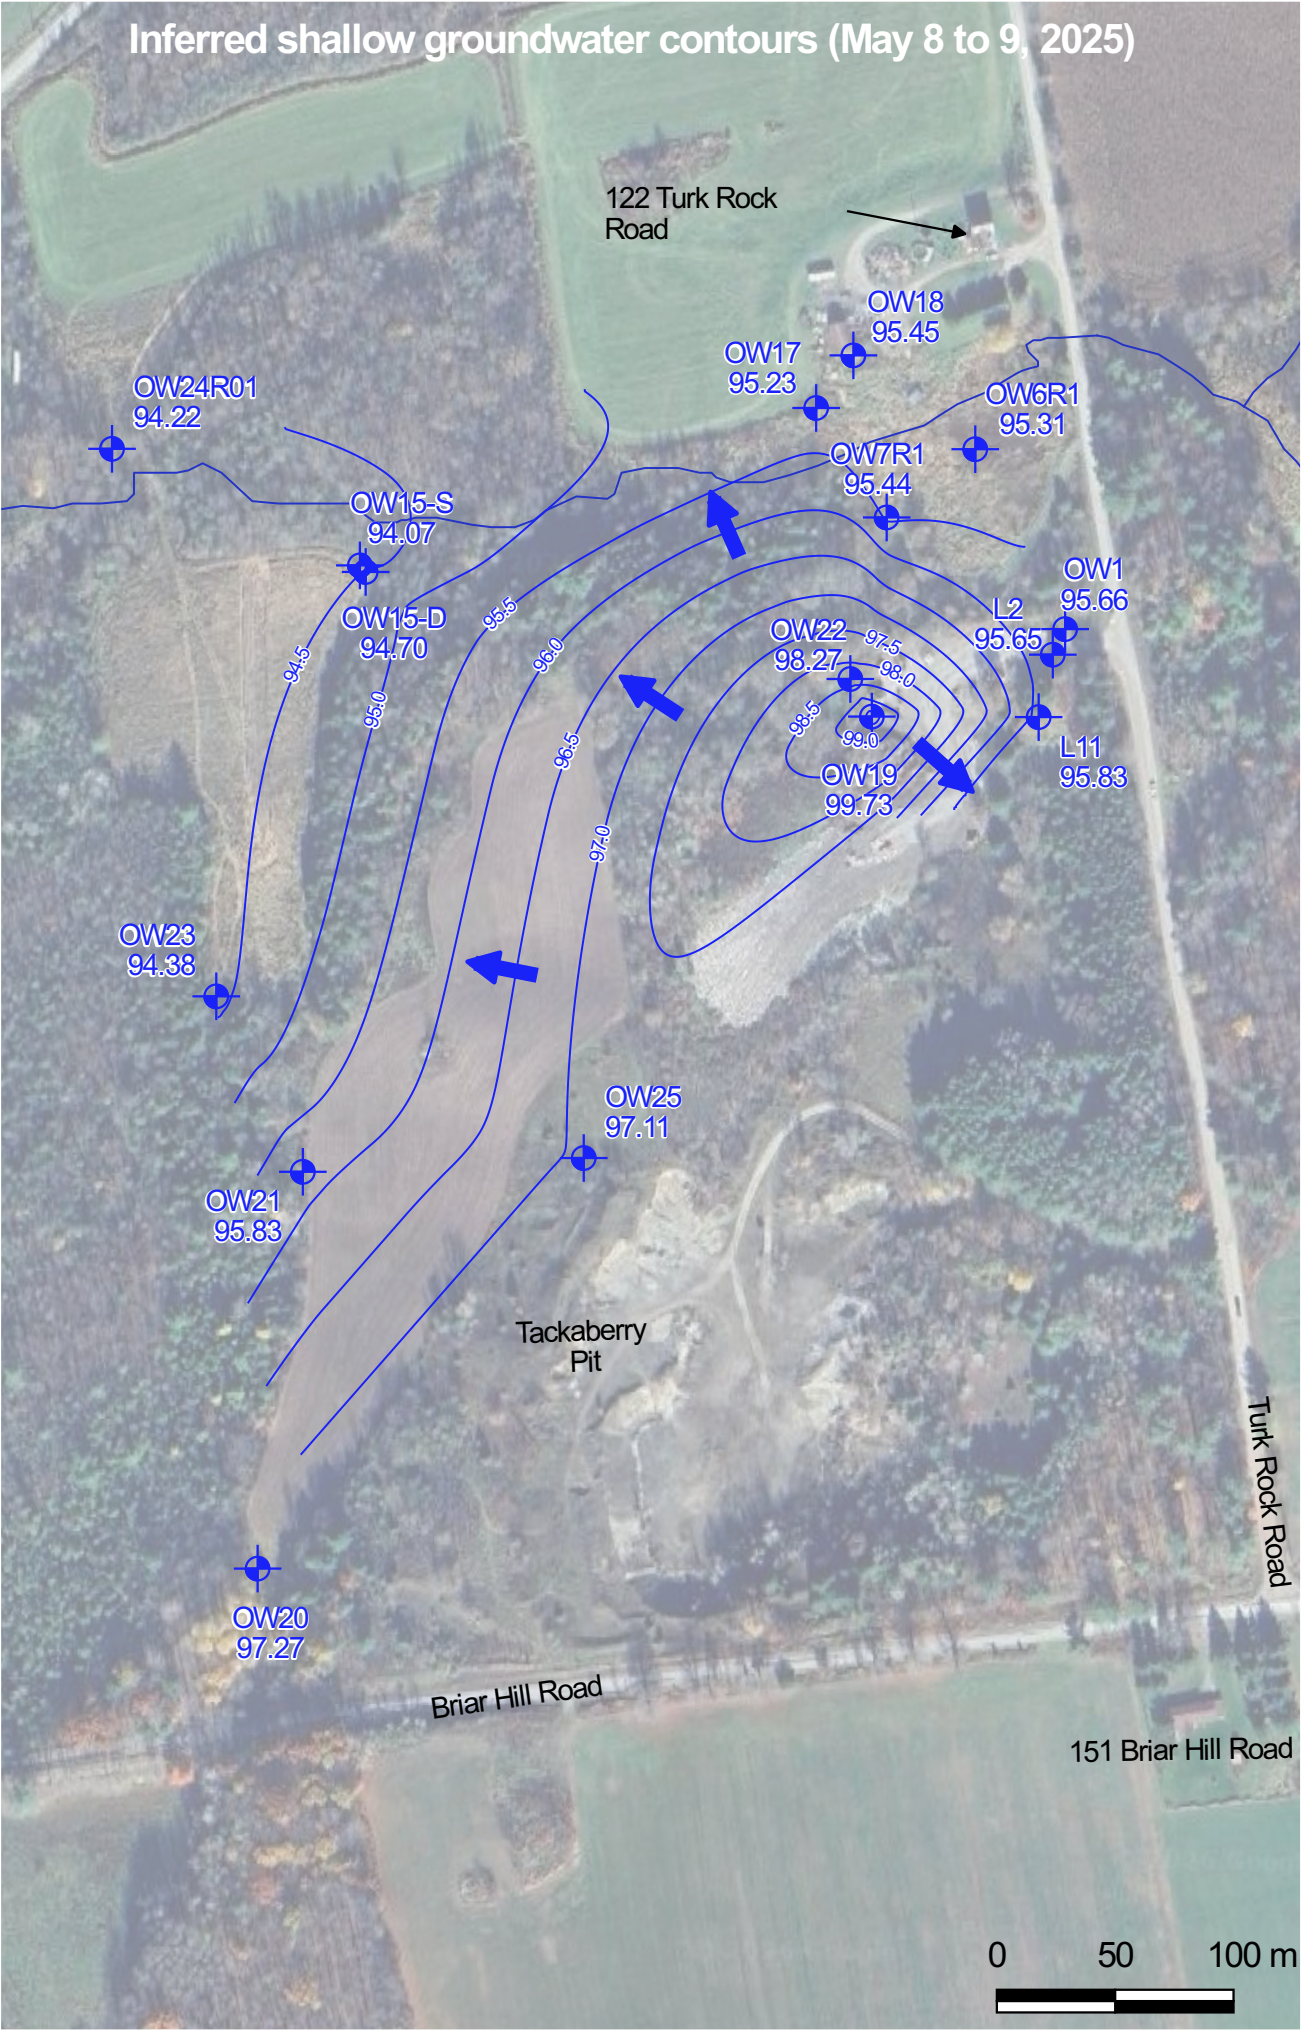
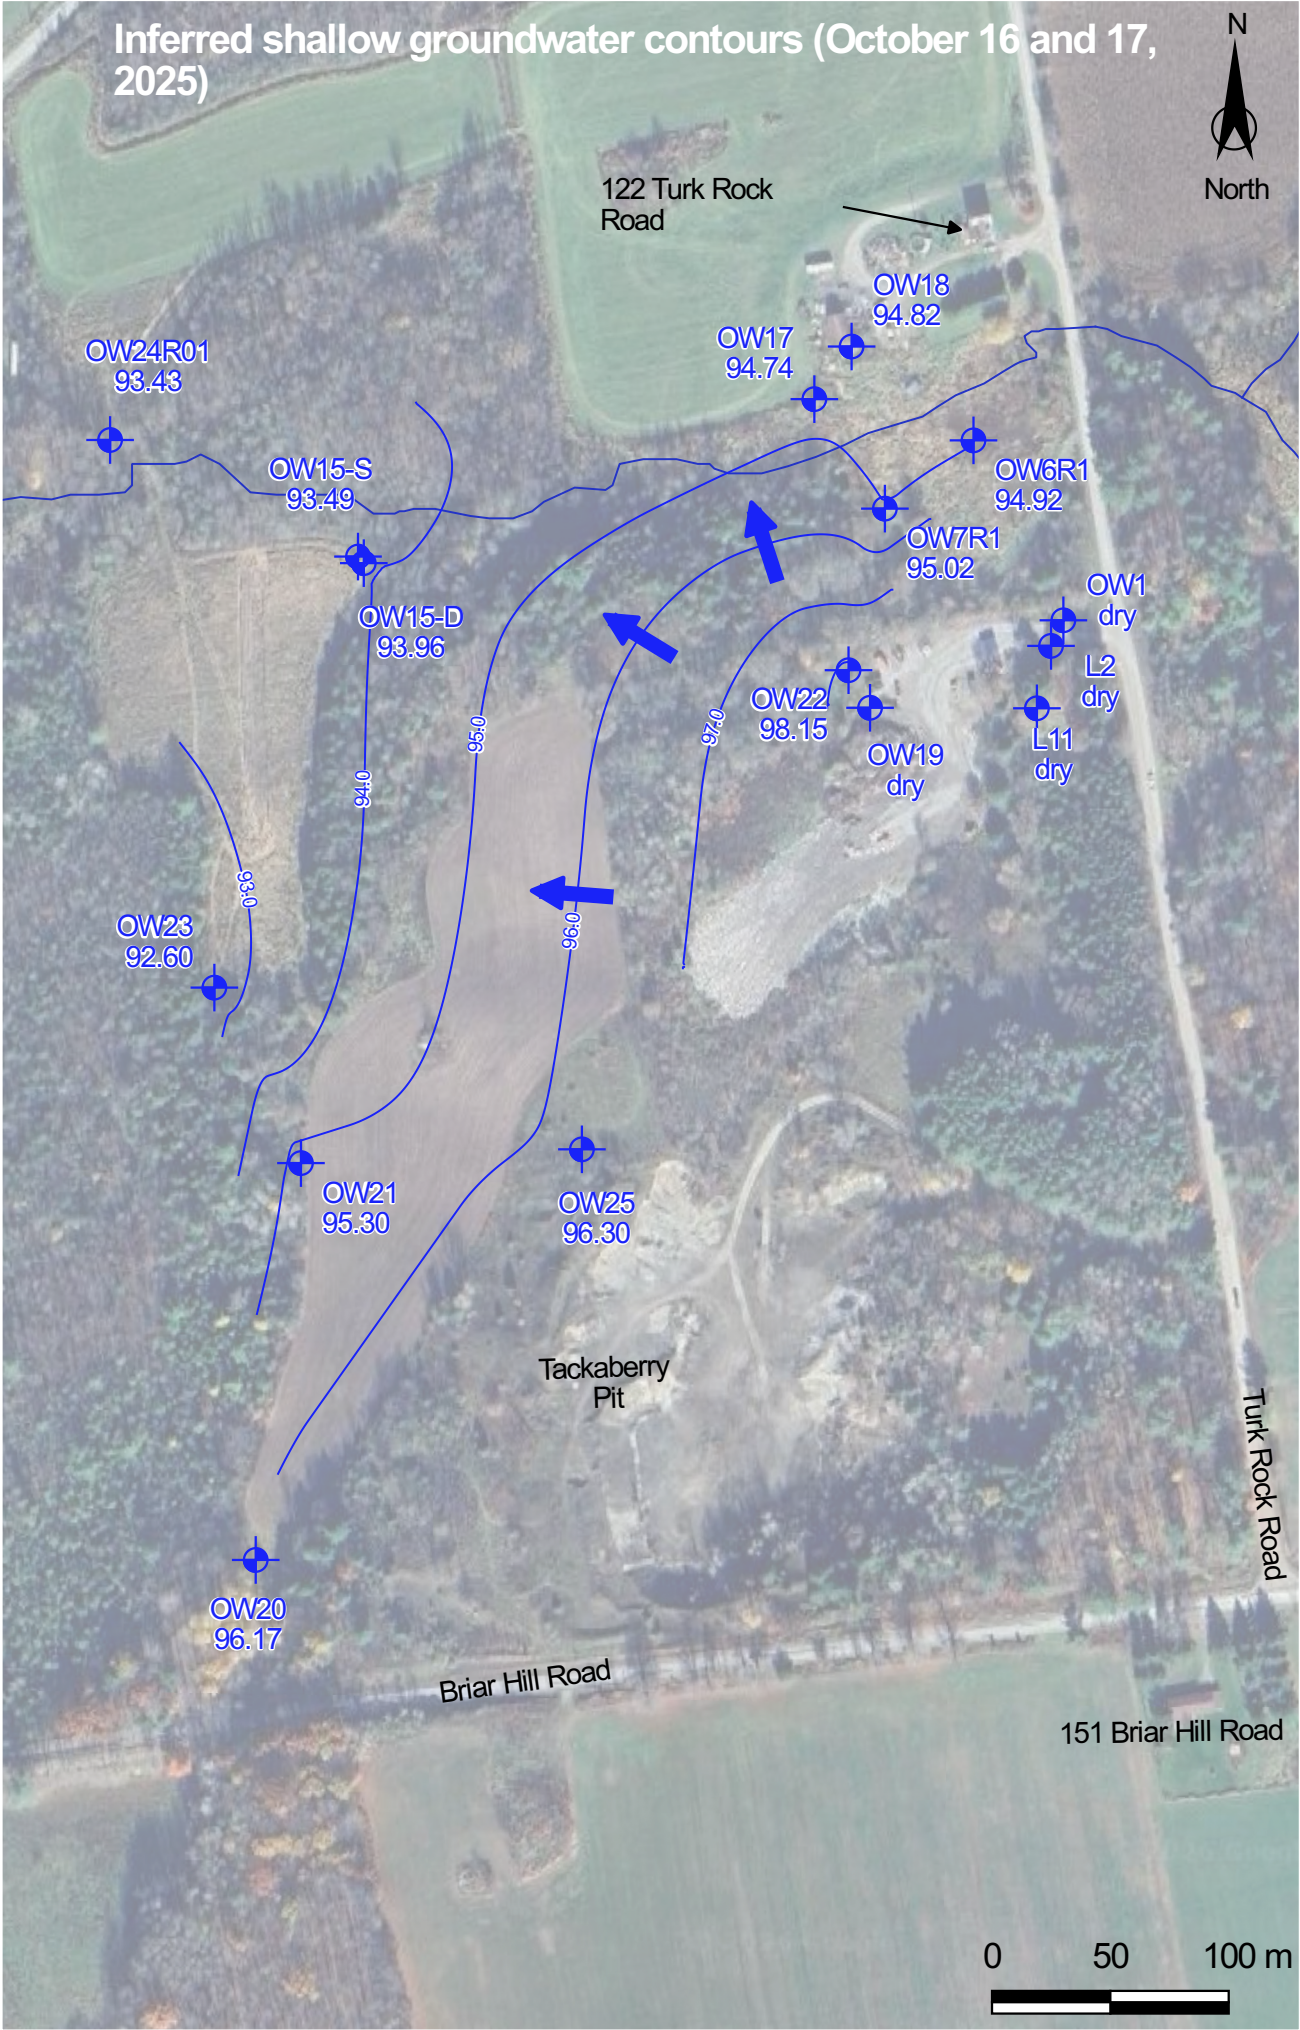
- Legend**
- approximate location of shallow groundwater well location and elevation (masl)
  - stream
  - inferred groundwater contour (masl; 0.5m intervals)
  - inferred direction of groundwater flow

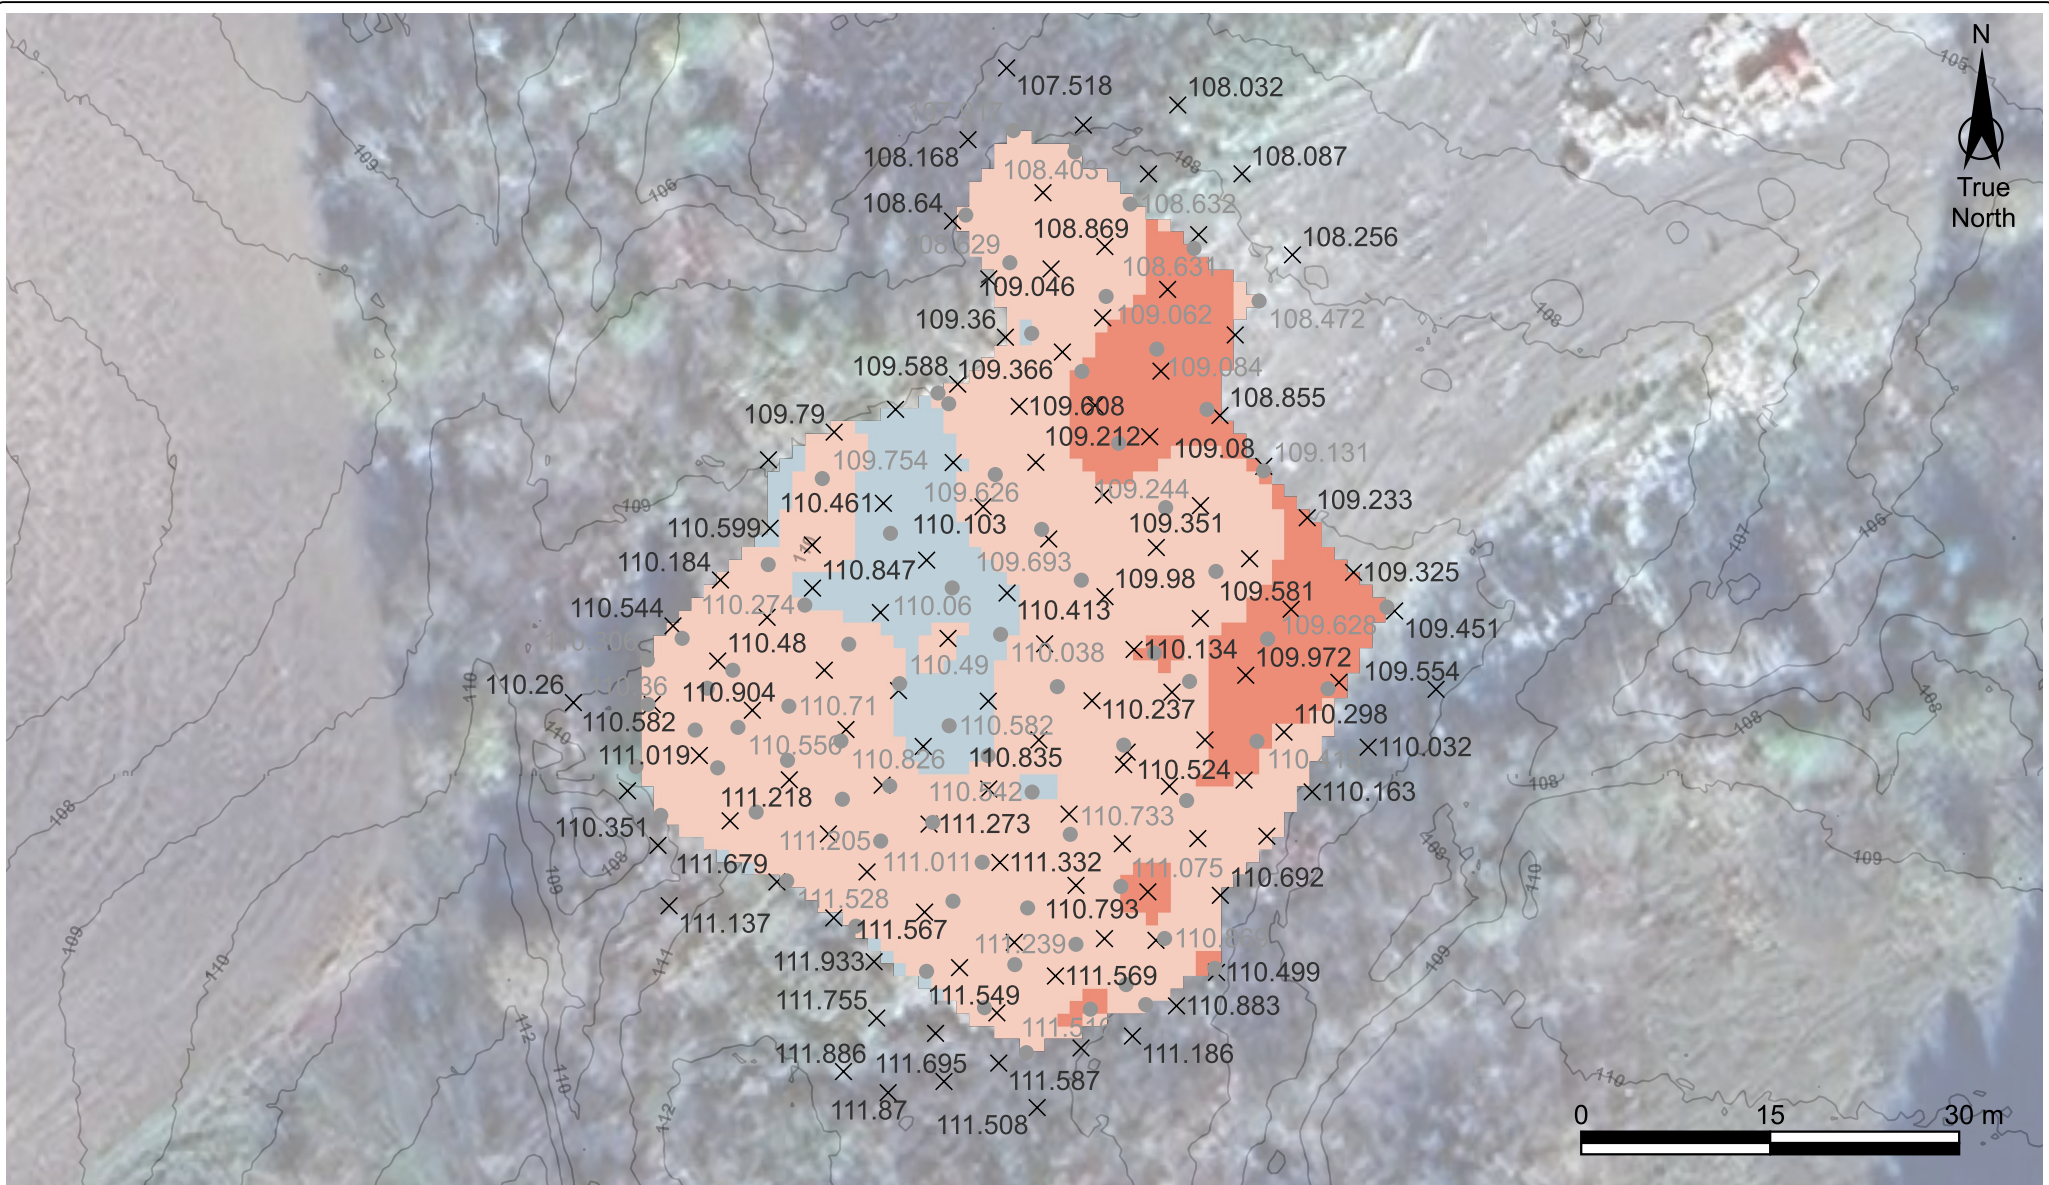
| File: 1036-128.00 | | Figure<br>6 | | |

- waste contour line and elevations (2025)
- ×

Data Sources: Figure based on Malroz field observations, Google Earth imagery, and survey conducted by Malroz on December 10, 2025.

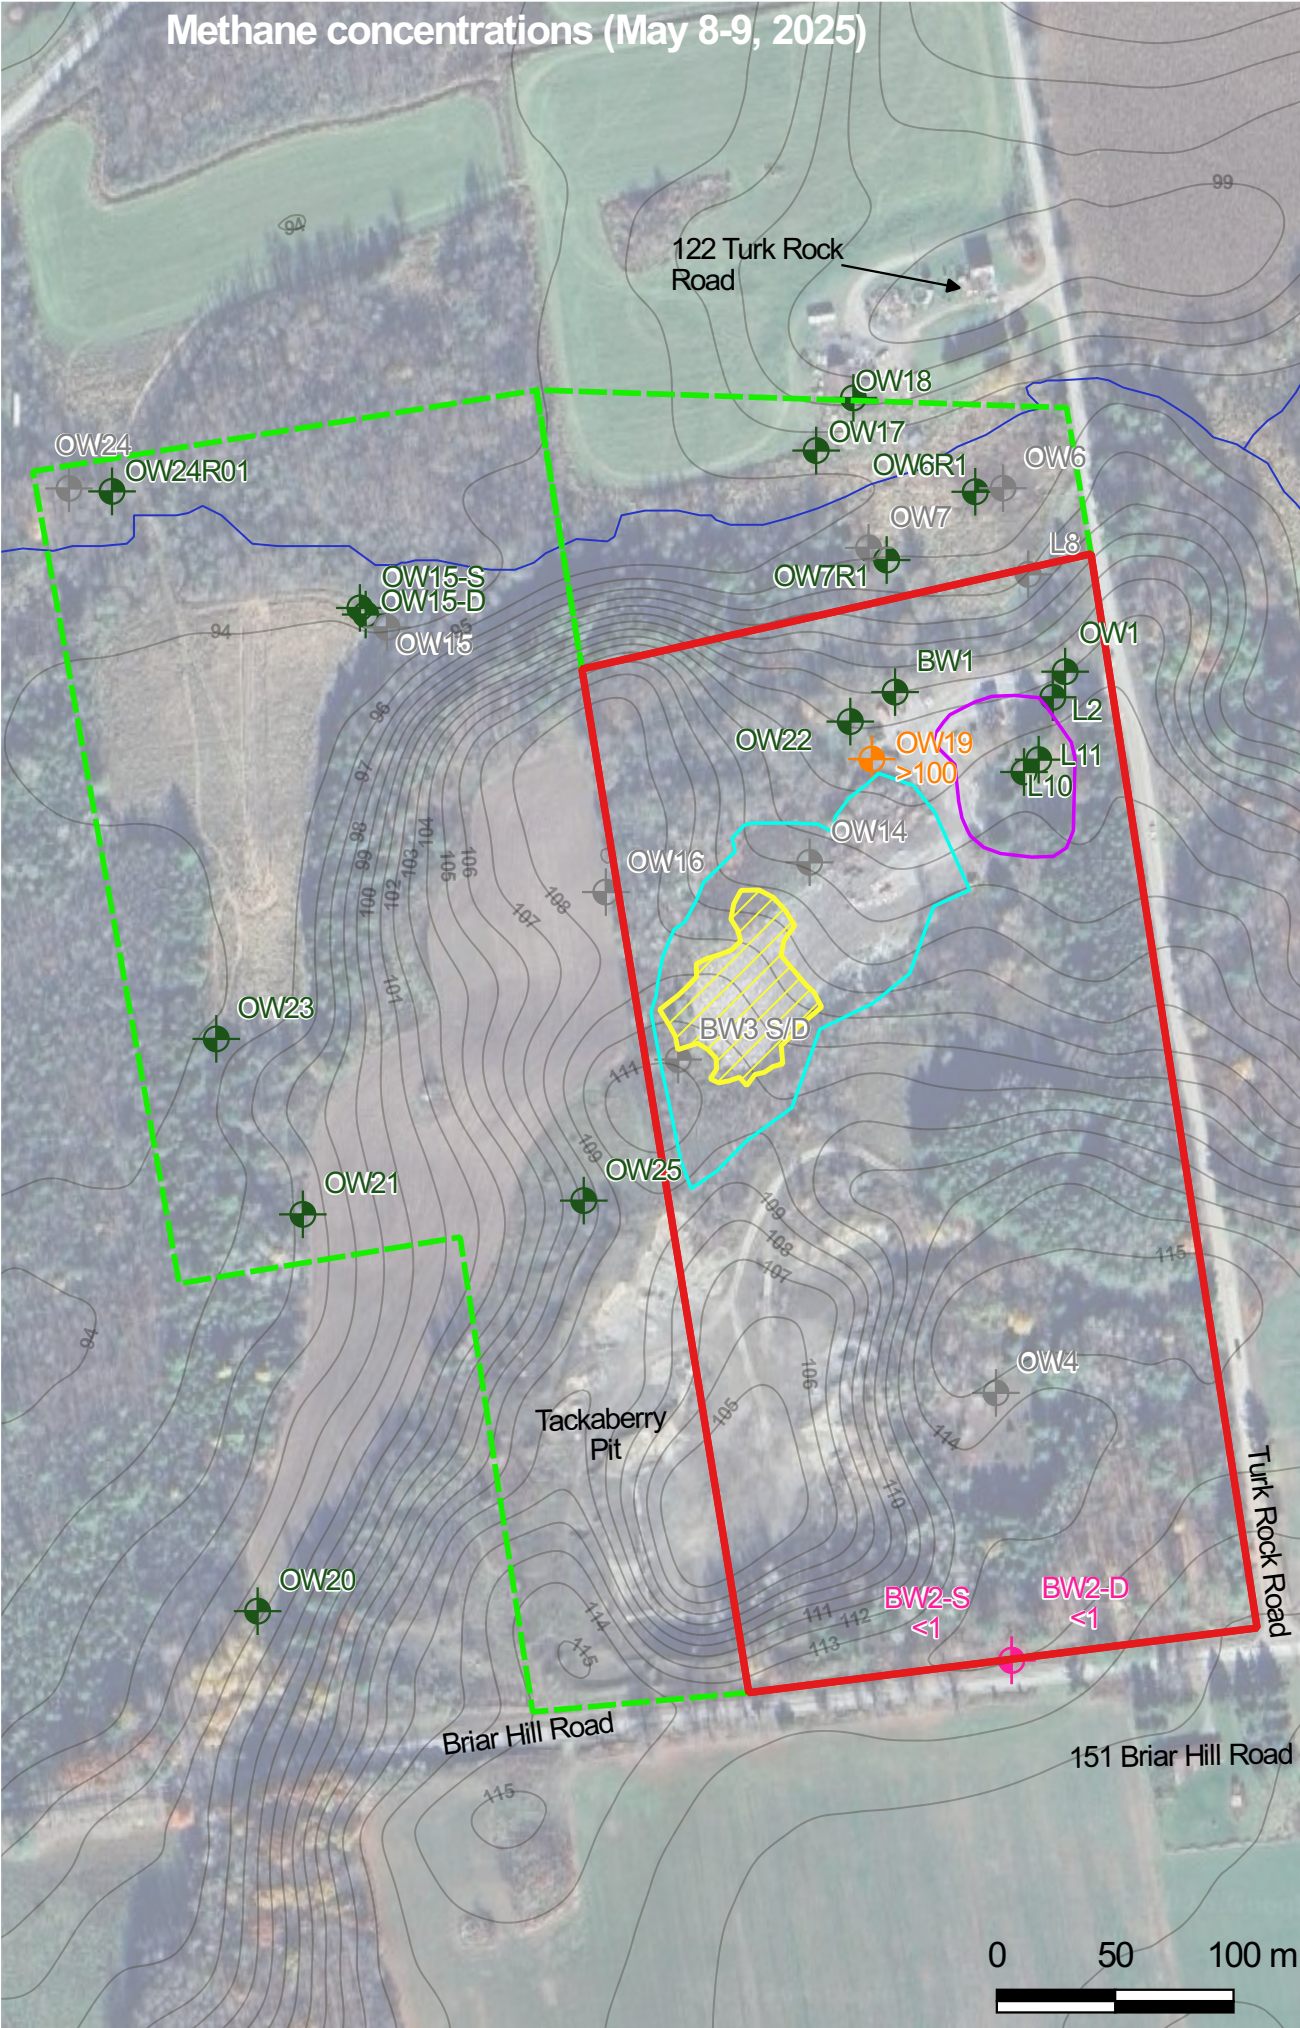
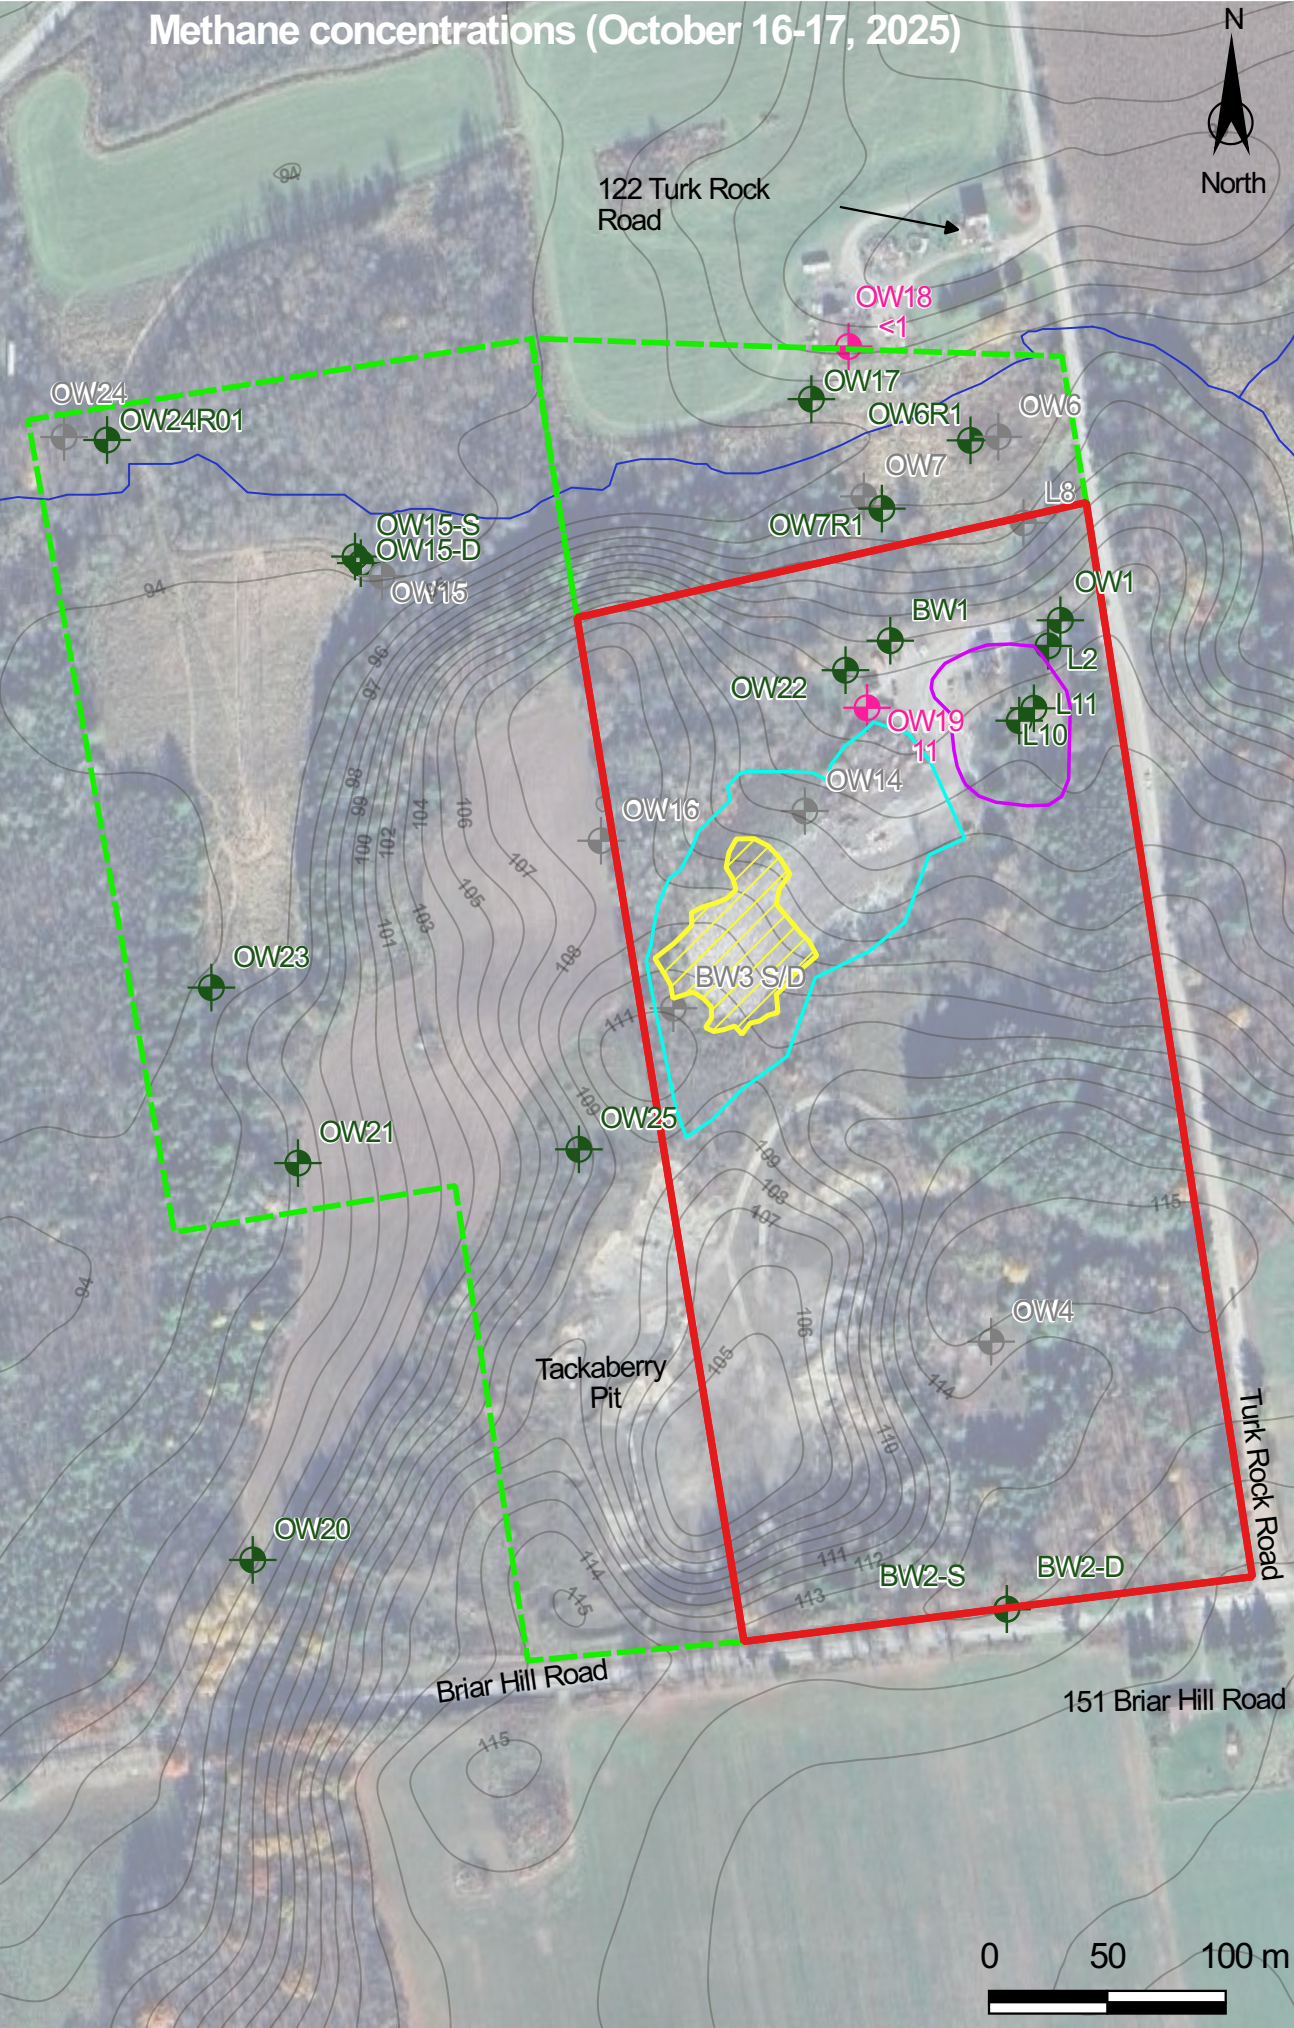
Methane Monitoring Results

- approximate site boundary
- approximate CAZ boundary
- approximate current landfill area
- active landfill area
- approximate old landfill area
- approximate topographic contours (MNRF, 2024)
- methane monitoring result no response
- methane monitoring result <20% LEL
- methane monitoring result >20% LEL
- well abandoned
- stream

D-4-1 Assessing Methane Hazards from Landfill Sites sets 20% of the LEL as a threshold limit to assume property adjacent to the landfill is not impacted. This threshold was exceeded at OW19 in the spring, where the reading was greater than 100% of the LEL. Concentrations at this well have exceeded 100% of the LEL since 2018 (see Table 8, Appendix B and Section 5 Response to Ministry Comments from Briar Hill 2024 AMR, Appendix E). As seen in Figure 7, OW19 is the only well that reports elevated methane concentrations in the area; BW2-D and BW2-S are background wells to the south of the site, and are not likely to be impacted by methane from either the old or new landfill sites. The Site conceptual model has flow in the overburden discharging to the water feature to the north of the Site, and south of 122 Turk Rock Road. The overburden is permeable with a high sand content.

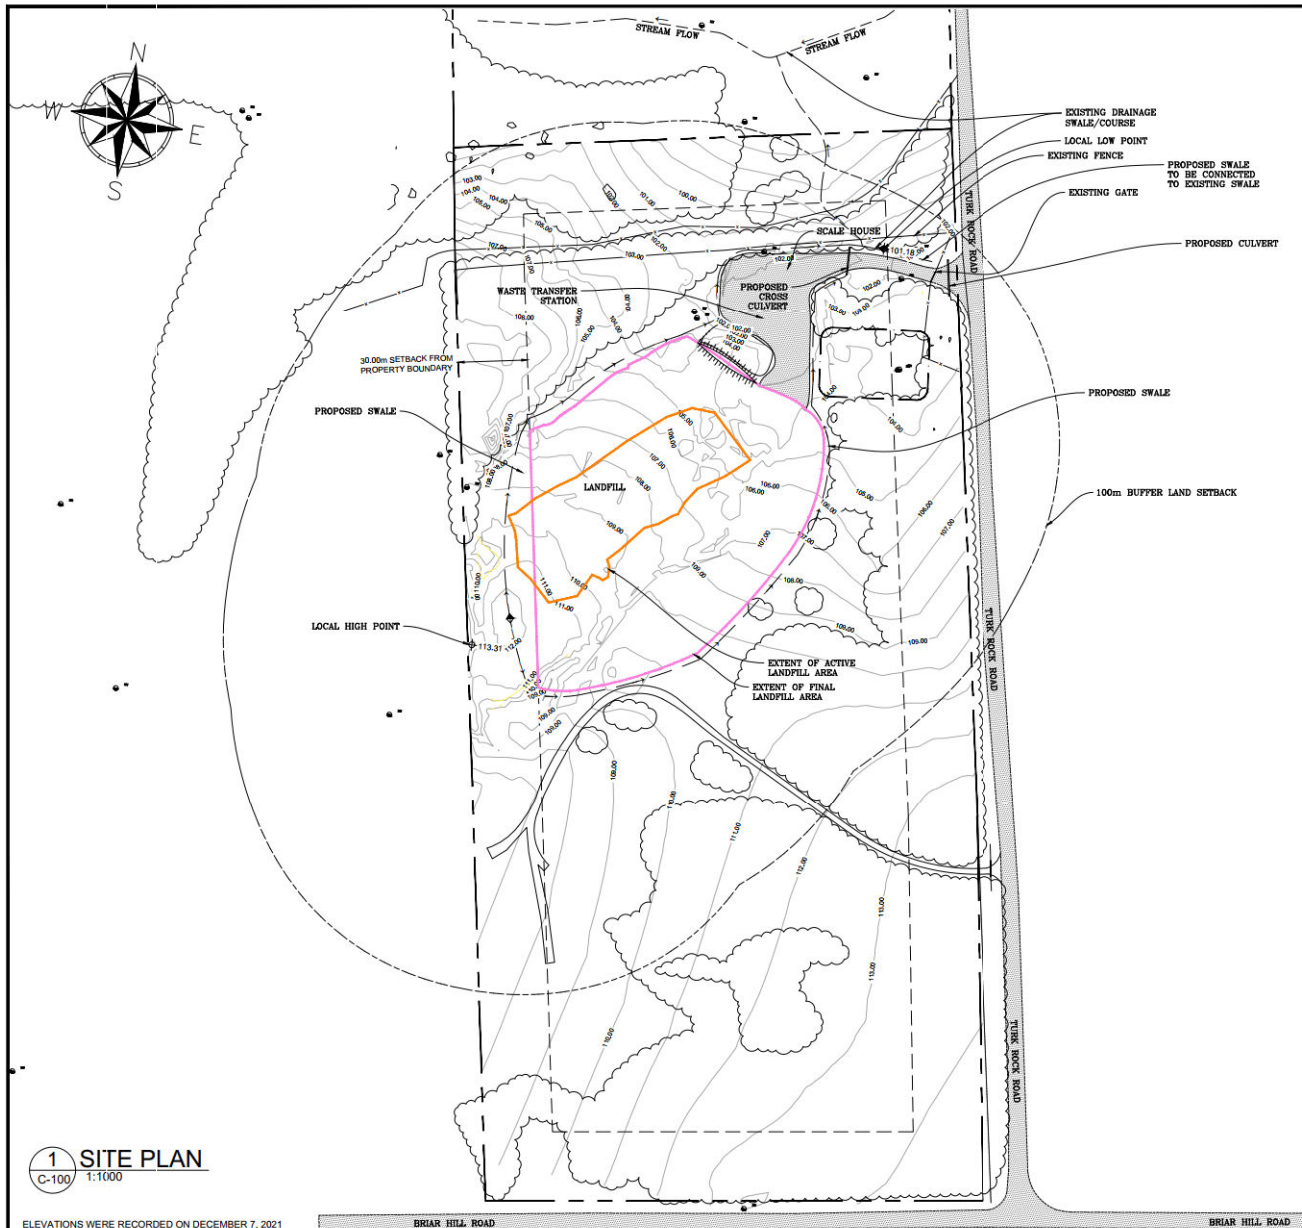
# 1 SITE PLAN C-100 1:1000

ELEVATIONS WERE RECORDED ON DECEMBER 7, 2021  
USING CAN-NET GNSS REAL-TIME CORRECTION  
NETWORK

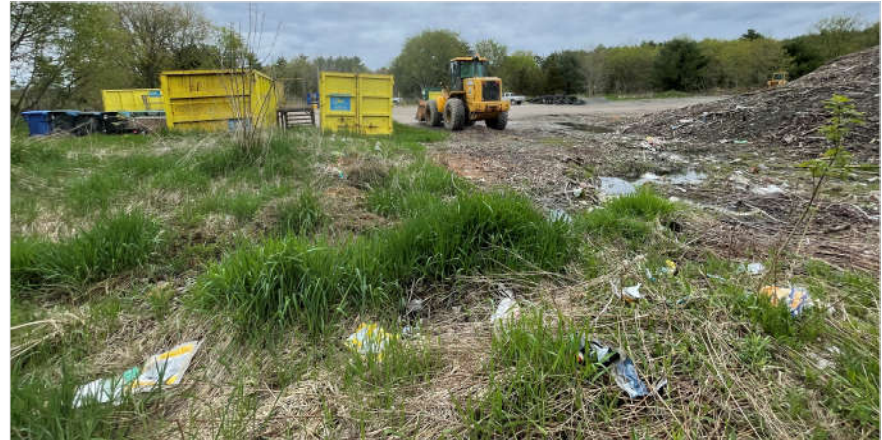
Photo 2: Wind blown litter.

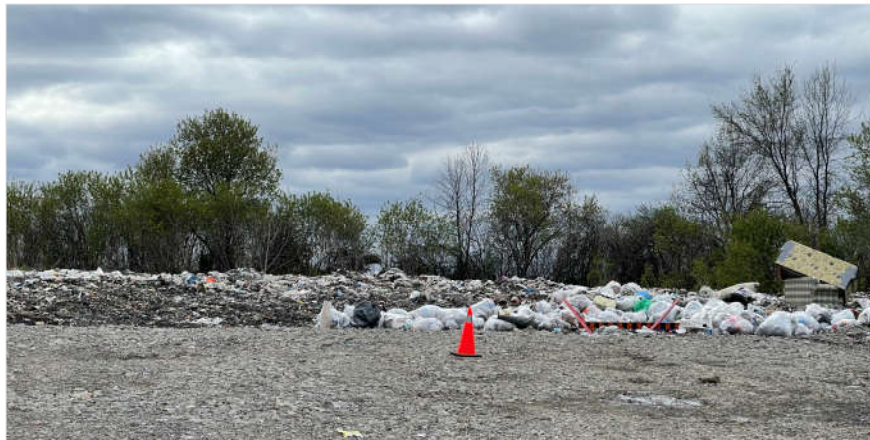
Photo 3: Active waste pile.

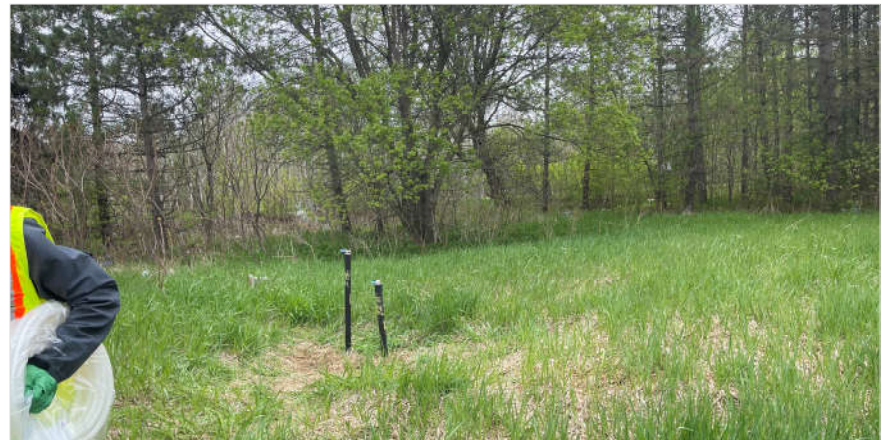
Photo 4: L11 (Left) and L10 (Right).

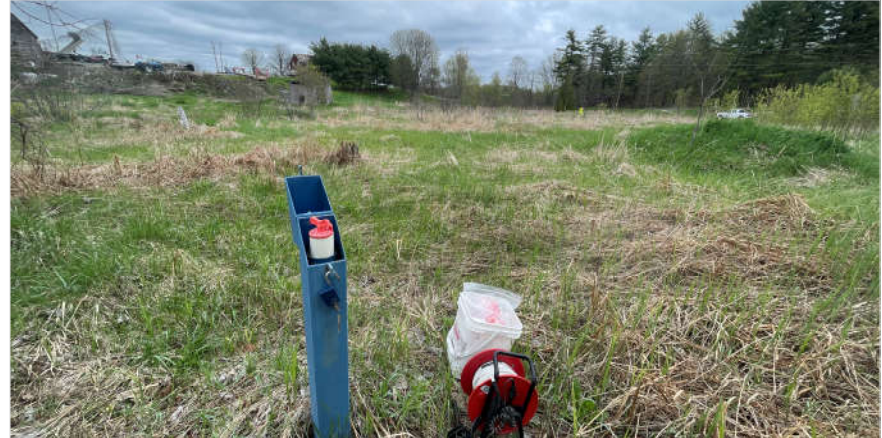
Photo 6: Well OW7R1 facing north-east.

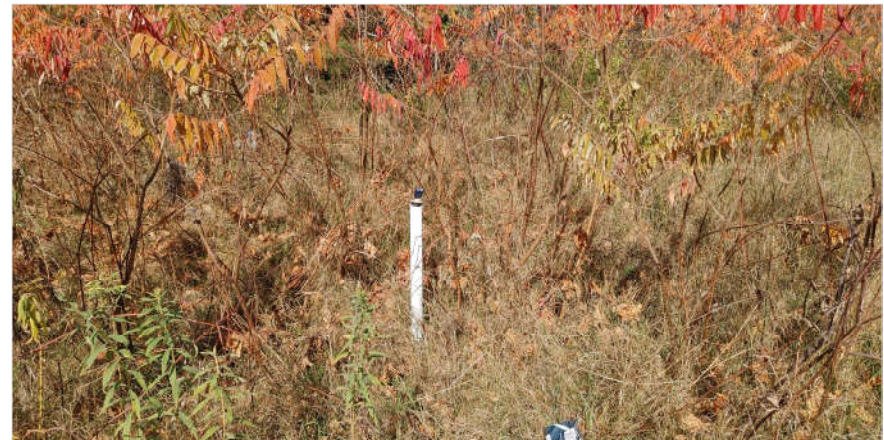
Photo 12: OW1 facing north.
