# OPERATIONAL ASSESSMENT REPORT

## LION'S HEAD MARINA

LION'S HEAD, ONTARIO

**Re: Operational Assessment of the Lion's Head Marina**

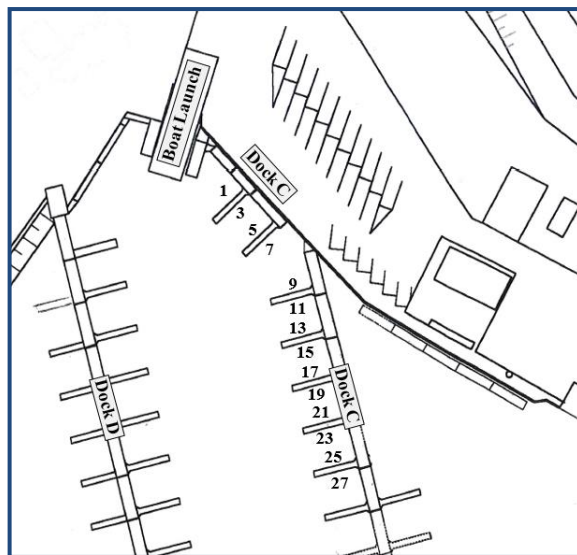
Figure 0-1: Proposed Location of Commercial Zone in Lion's Head Marina

Should the marina staff wish to assign an area of the existing floating docks to commercial vessels, we recommend slips 1, 3, 5 and 7 of Dock C. Should commercial activity in the marina grow beyond the berthing area provided by these four 30 ft slips, this commercial zone could be extended to the odd-numbered slips from 9 to 27 on Dock C. See Figure 0-1 for a diagram showing the location of these slips.

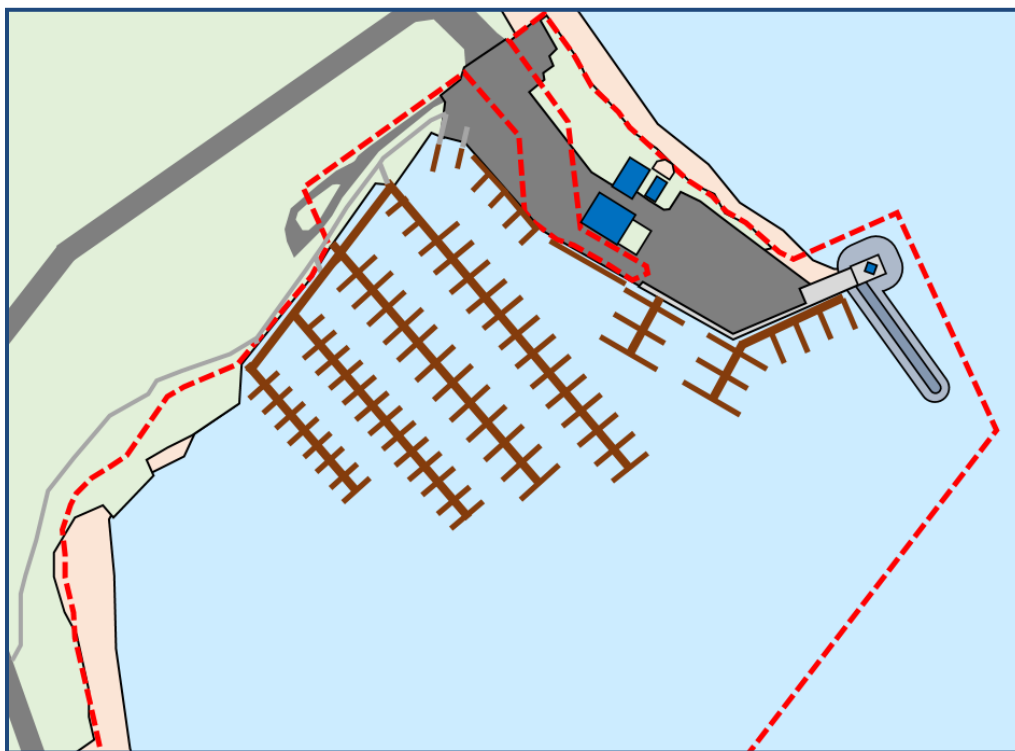
*Figure 4-2: Dock Reconfiguration, Alternative 1*

The first alternative dock reconfiguration involves moving Dock C to the west, next to Docks D-F, and rearranging the pieces of Docks A and B to form a new Dock B extending from marina wall south of the service docks, as well as a new Dock A running along the marina's south wall before extending out towards the southwest. See Figure 4-2, above, for a conceptual plan.

The downsides of this layout include the need to rearrange many of the docks, which can be time-consuming and costly. This new arrangement also increases walking time for private/residential boaters from the parking areas. Docks C-F would be placed closer together, but this would not significantly affect maneuverability.

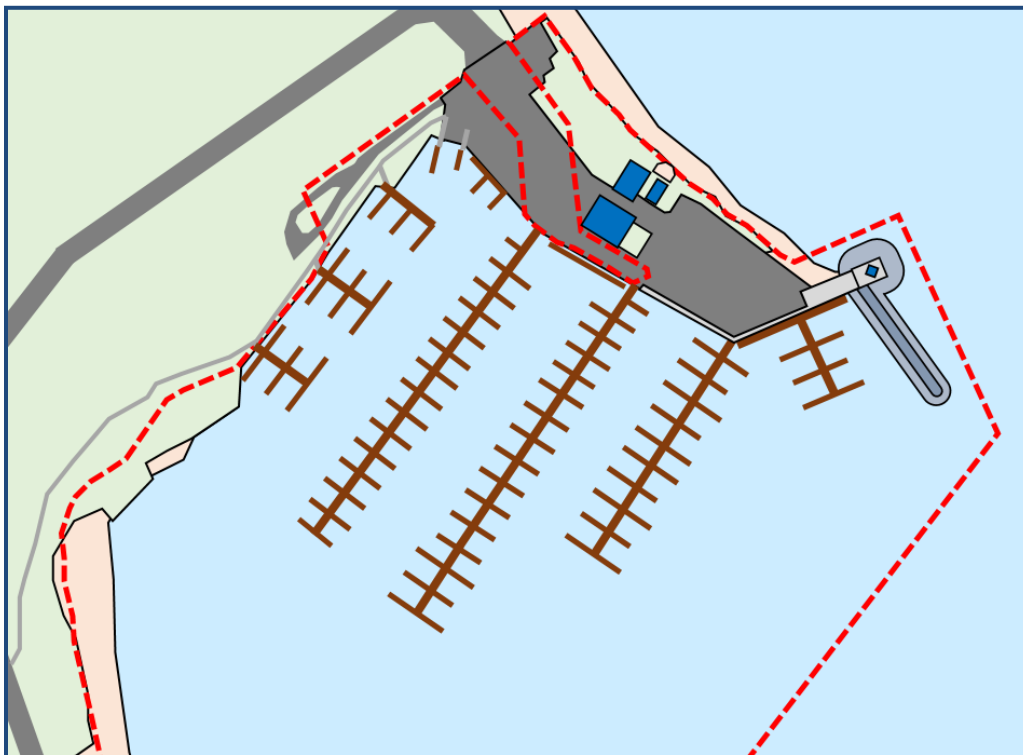
Figure 4-3: Dock Reconfiguration, Alternative 2

The second alternative reconfiguration involves rearranging the alignment of the docks to match that of the service docks and adjacent shoreline to the north. A new dock (new Dock C) can be added on the east side of the service docks. The existing Docks D-F (now Docks E-G) are shortened to become finger docks. See Figure 4-3, above, for a conceptual plan.

Benefits of this alternative include relocating Docks A and B to avoid the unprotected area behind the breakwater, providing immediate parking lot access to boat users from the parking lots to the vast majority of slips, and wide spacing between the docks, providing improved maneuverability. Drawbacks of this alternative include the need to rearrange many of the dock sections, the lack of direct access between the service dock to the boat launch, and the need for boats to travel further in the harbour on average to get to Georgian Bay from their slip.

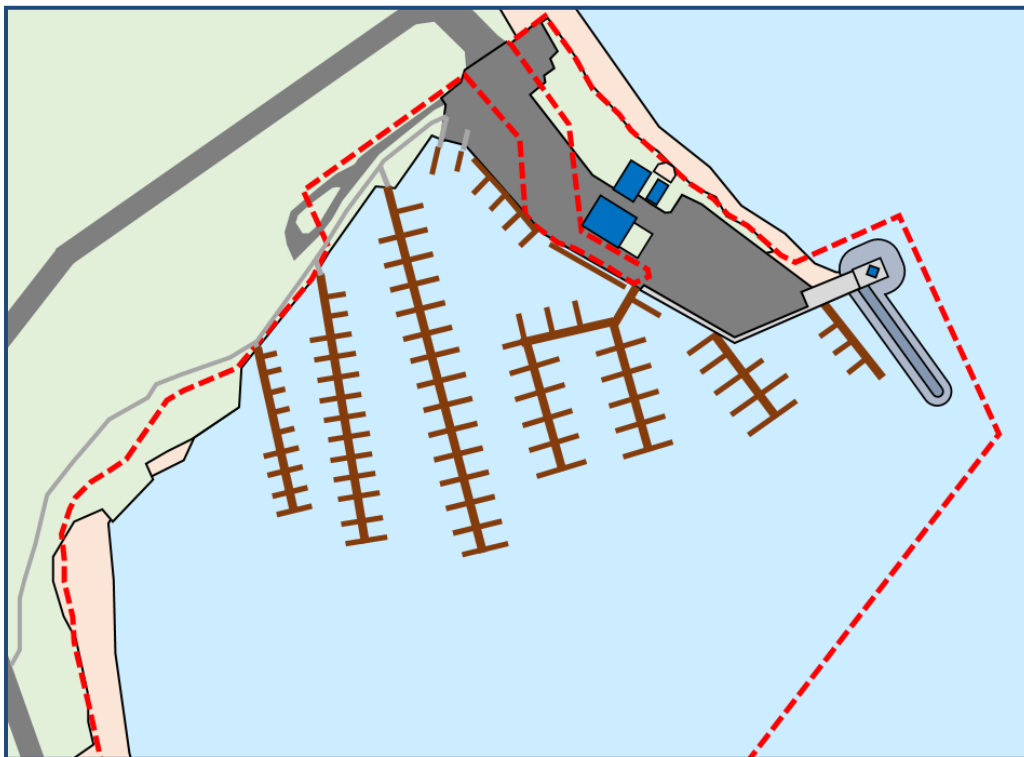
Figure 4-4: Dock Reconfiguration, Alternative 3

The third alternative reconfiguration primarily involves changes to Dock C. Its sections have been rearranged such that the new Dock C is accessed from a point immediately east of the service dock. This dock then branches into Dock C1, which extends southward, and Dock C2, which extends eastward before bending 90° to the south, after which it is aligned with Docks C2 and D. Docks A and B are shortened, and Docks D-F largely remain the same. See Figure 4-4, above, for a conceptual plan.

One main drawback of this alternative is the lack of sheltering from the harbour's rough weather conditions. While Docks A and B have been shortened slightly, the existing issues with damage from weather conditions will largely continue. Another drawback is that at times when the public boat launch ramp, service dock, mast crane and fuel pumps are all in use, the area of the harbour between Docks C and D will become very congested.

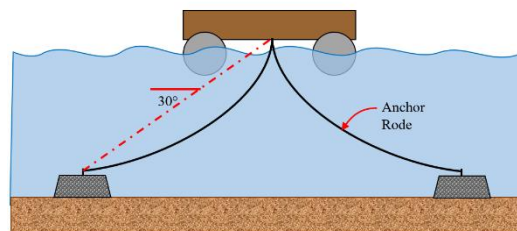
Figure 5.1: Deadman Anchoring Method

However, compared to the other methods listed in this report, deadman anchors are the least stable. As the weights are not driven or dug into the waterbed, they can be moved or shifted by much smaller forces than those required to move soil anchors or piles. The stability of deadman anchors depends on the size of the weights used, where heavier weights result in increased stability, as well as the type and quality of the soil at the surface of the waterbed, where siltier, clay soils provide less support than sandier soils.

As mentioned in section 5.2.1, above, the floating docks in the Lion's Head Marina are concrete deadweight anchors. For the most part, these anchors are capable of holding their docks in place. However, due to the extreme and severe weather conditions acting on the floating dock system, the floating dock system fails. Planmac does not believe, however, that the failure of the docks during storms is a result of the anchoring method. The docks are subjected to such large forces during these events that if a stronger anchor were able to hold the docks in place, they would simply fall apart and detach. While past storms have caused anchors to shift and move, they have also caused welded steel joints to tear apart and anchor rode to snap.

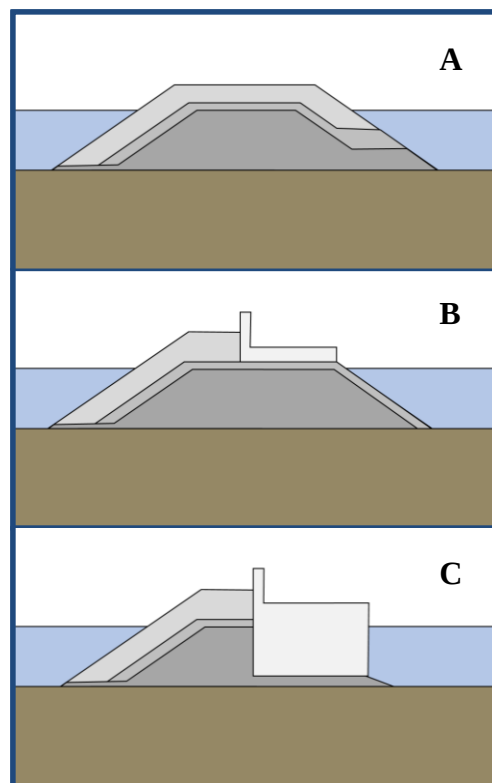
Figure 6-1: Breakwater Types – A) Rubble Mound Breakwater, B) Rubble Mound Breakwater with Concrete Walkway, C) Composite Rubble Mound/Concrete Vertical Wall Breakwater

The type of breakwater structure implemented depends largely on the weather conditions, but also on operational considerations. Types of breakwater structure include vertical sea walls, floating offshore breakwaters and curved breakwater walls. However, the most durable type under the extreme conditions experienced at Lion's Head is a rubble mound breakwater. This is the same type of breakwater as the existing structure, consisting of layers of rocks and fill of varying size. However, this breakwater method can be altered to suit the needs of the harbour, and can be built with armour stone all around, with a concrete walkway on the lee side, or as a composite of a rubble mound and concrete vertical wall, as shown in Diagrams A, B and C of Figure 6-1, respectively. A concrete walkway would provide a safe area from which Lion's Head visitors could photograph the iconic lighthouse, without the dangers associated with climbing across armour stone. A composite mound-vertical wall could provide a solid wharf on which larger vessels could be moored, increasing the useable mooring space of the harbour. The concrete components of these types of breakwater structures provide more utility, but add to the cost of the wall's construction as well as its design. Other types, such as partial depth or pneumatic breakwaters could also be considered.

We recommend that the existing breakwater structure be removed, and, where possible, salvaged and rebuilt into a new armour stone breakwater structure. This new structure would be taller than the existing structure to more adequately shelter the marina from Lion's Head's strong winds, and would be longer to provide more protection from diffracted waves. The new structure would be built to the east of the existing structure to provide more useable space within the marina.

We also recommend that the Municipality give consideration toward the implementation of a concrete walkway along the lee-side of the new wall. While this will not have a significant structural effect on the wall, it will provide a safer environment for marina visitors wishing to capture photos with the site's iconic lighthouse and vistas.
